FINAL DRAFT

Point Molate Bay Trail
Coastal Erosion Assessment

Nichols Consulting Engineers

A-N West, Inc.
Consulting Civil and Structural Engineers

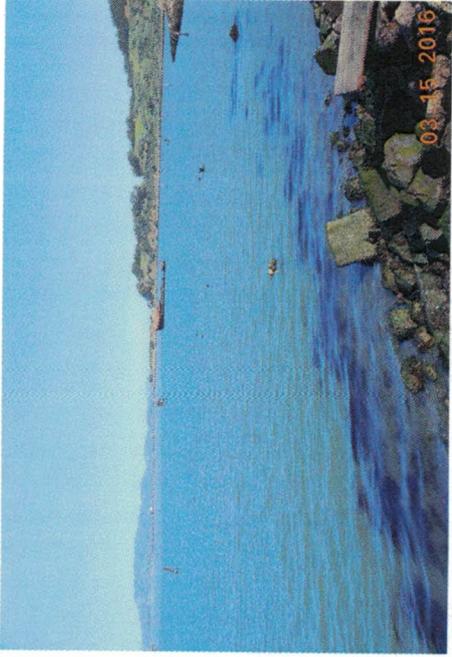
DSCN1866

Location	Description	Photos	Historical
A TO B	Rock strewn foreshore slope 10:1 to bluff protected with old pile & conc block debris. Sheltered from S and SW by Chevron Long Wharf	871 872	
B to C	Sand beach foreshore, 60' wide at LW, slope 10:1, bank riprap to MHHW.	873 874 875	
C to D	Rock fragment strewn foreshore, slope 10:1, bank protected with rough placed varied stone, rock, & concrete demo debris up to MHHW. Varied degree of protection. Rock up to 5 ton. Vegetation above MHHW.	876 877	
D to E		877 869	
E	Point Castro. Remnant of old ferry. Wood pile wave barrier, top at +1 MHHW with batter piles. Concrete block riprap raised up to floor elevation of old building. Dock with wreck.	866 867 868 869	Site of former ferry to San Rafael prior to bridge in 1956.
E to F	Old stone and concrete block from demo up to MSL. New concrete block from demo above MSL nearer to Point Castro. Concrete riprap to MHW beyond, with stack of old wood piles in close proximity.	866 865 864 878	Remains of old dock present.

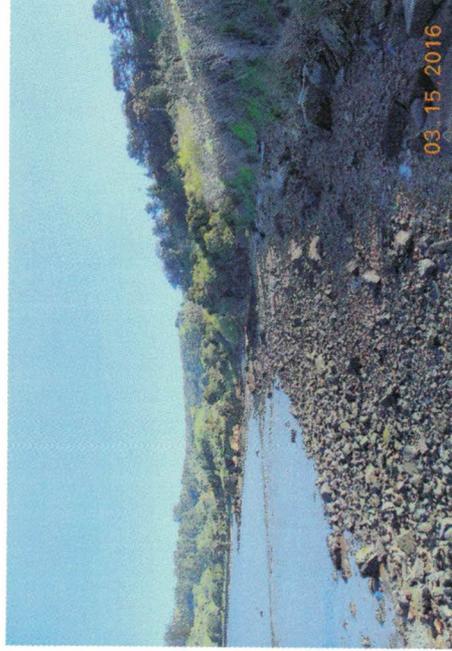
DSCN1863

G	Marsh area with mud flat. Recent 24 inch +/- stone protection to the bank in west direction.	863 864 879	
H	Sand beach foreshore, up to 50' wide at LW, slope 12:1. ?photo	861 862	
I	Sand beach foreshore, 50' wide, up to MHHW at 10:1 slope. Flat 40' wide backshore to steep cliff, both vegetated.	881 882 883	
	Point Molate Beach Park.	884

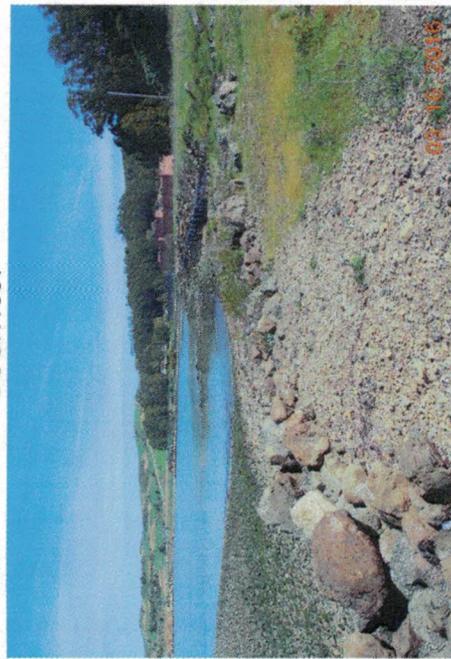
DSCN1898

Location	Description	Photos	Historical
	Point Molate Beach Park	914 915 916	
A	Sand and rock strewn foreshore at 10:1 slope, steep rock bank, small rock at flatter slope, then 12' vegetated strip to AC pavement.	891	
B	Rock outcrop at foreshore up to MSL. Short rise of rock covered bank. Shallow vegetated bank slope back to AC pavement.	908 909 911 912 913	
C	Exposed cliff with surface. Steep slopes with light rock protection. New concrete demo pieces of 15" down in size. Grass bank at 20:1 up to AC pavement.		
D	rock fragment strewn foreshore. Loose friable rock cliff with some loose rock.		
E	Line of large rocks (5 ton +/-) at toe of cliff with small rock berm against cliff.	892 893	
F	Loose rock and some concrete fragments. Grading	895	
G	24" stone at 2:1 bank protection, loosely placed. Rock fragment strewn foreshore.	907	
H	Rock covered bank and timber pile (18" diameter+/-) wall with long piles stacked 3 high. A various rock, small stone, degraded sacked concrete above wall topped with a 2:1 3' high vegetated bank up to regraded area.	898

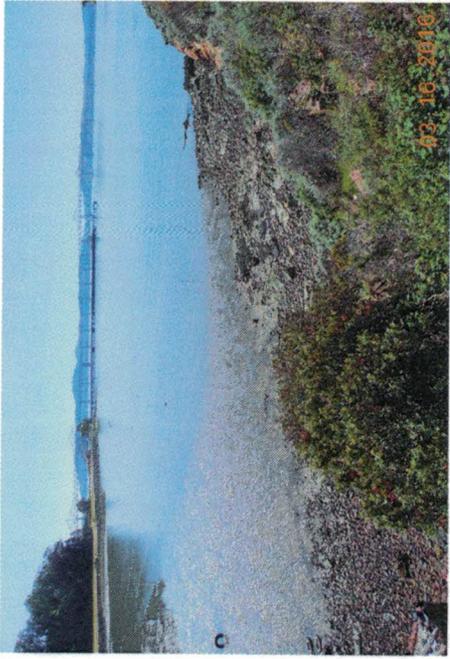
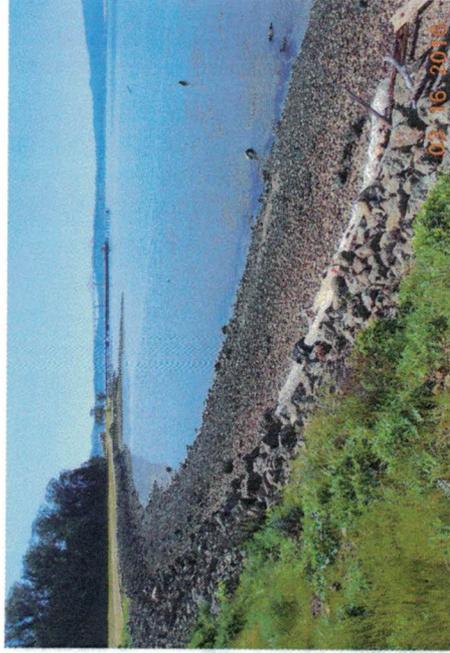
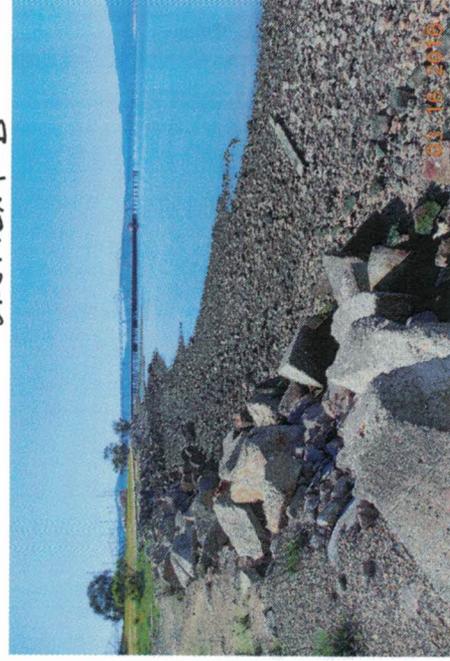
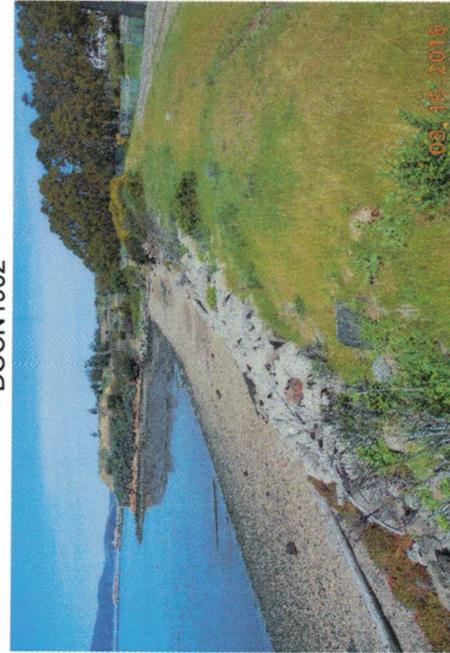
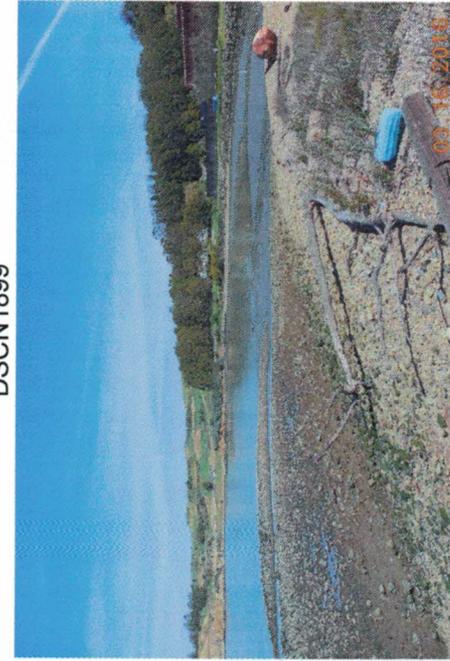
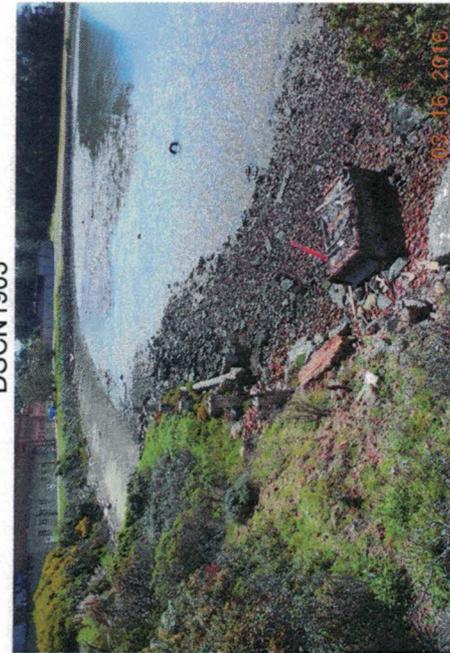
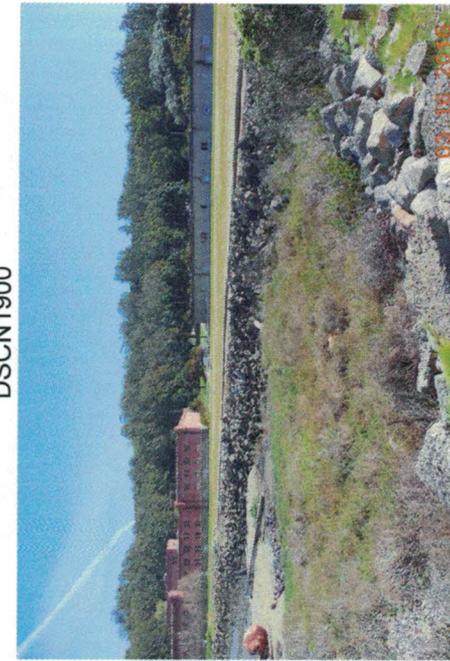
I	Some new rock on top and some concrete blocks on steep rocky slope Loose rock 15" +/- with intermittent timber piles and timber piled wall. Some new concrete cone protection 46" square base & 27" high.	899 900 901 906	
J	Beach with mud flat, foreshore with rock fragments and some sand, 2:1 rock bank and vegetated slope to flat graded and paved areas. Rock 24" to 6" angular.	902 903 904 905
