Project No.
11403.001.000

October 10, 2017

Subject: EBRPD Ridge Trail - Fremont
Fremont, California

GEOLOGIC CONSTRAINTS REPORT

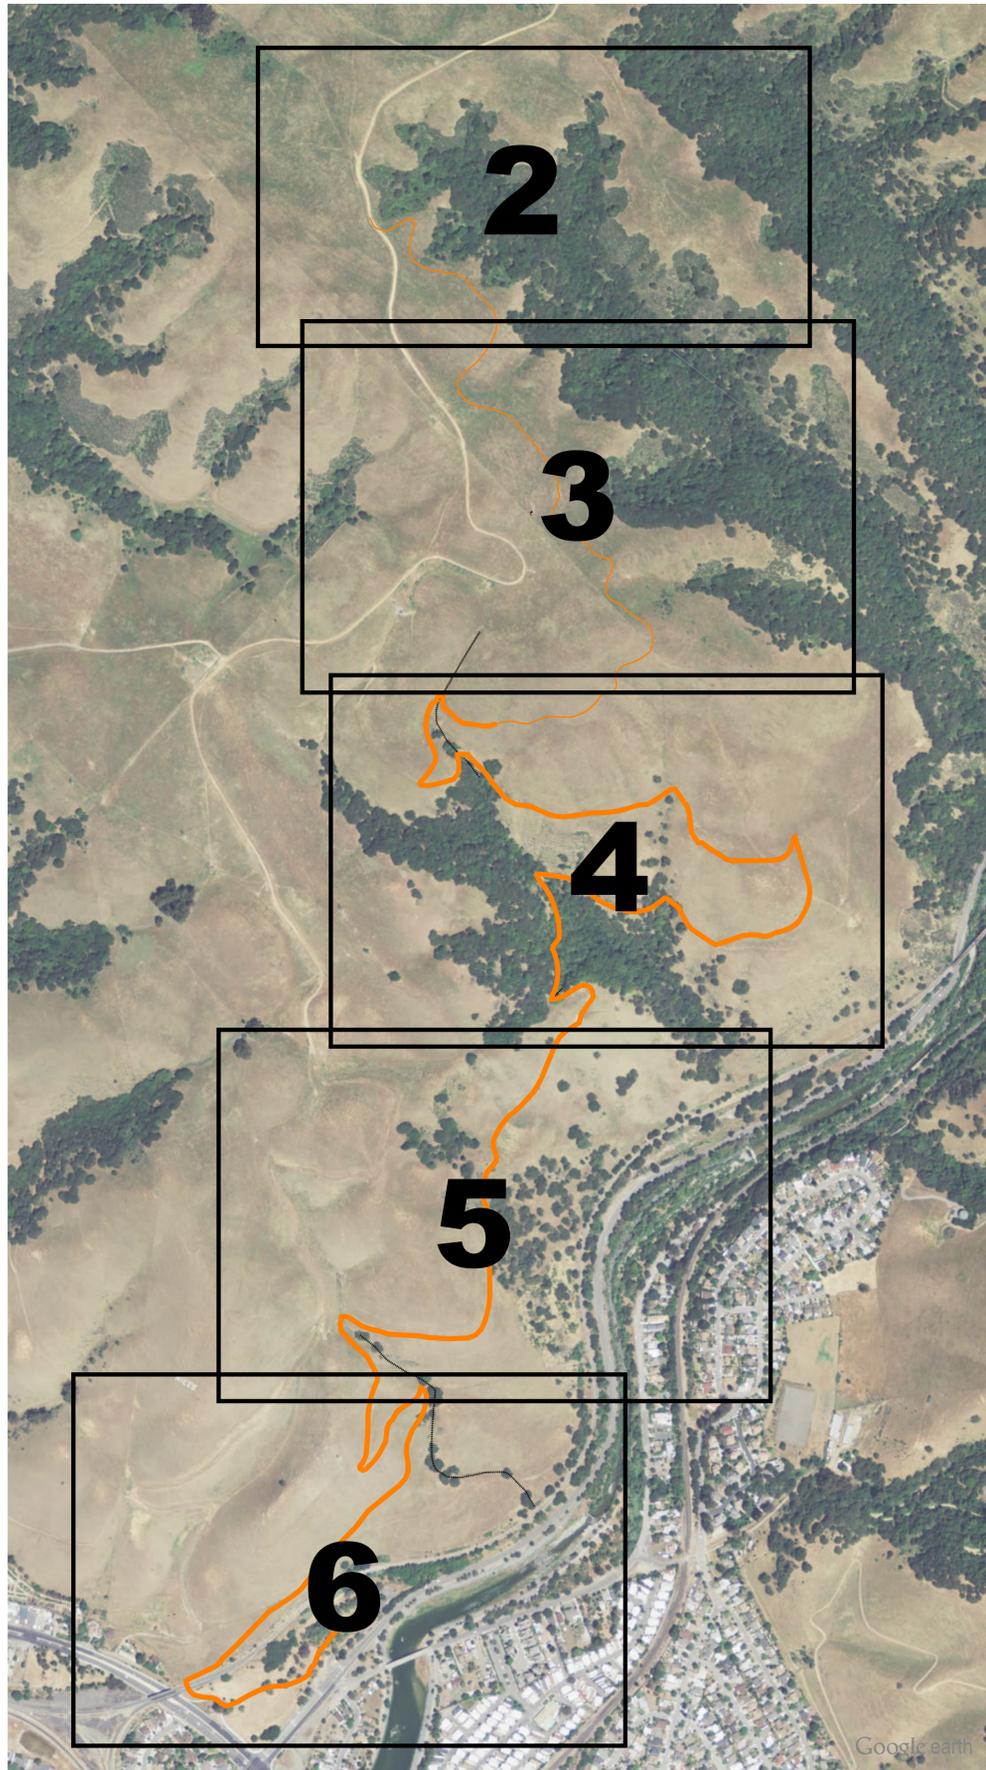
FIGURE NO. **1**

1. Bedrock Landslides: A number of deep-seated bedrock landslides have been identified in the area (Figure 1). A "bedrock" landslide is a slope failure whose basal slip surface extends into the underlying bedrock. The geometry of the slip surface can be curved, as in a rotational slump, or planar, as in a translational landslide. In both cases, relatively intact and

Several large landslide complexes occur in this geologic unit along the proposed trail alignment (Figure 1). Landslides within this unit vary from shallow earthflows to deep-seated bedrock landslides. Many of the larger mapped landslides are not considered historically active however many of them appear to be relatively young and susceptible to seismic induced landslide movement and capable of shedding smaller earth and debris flows especially where exposed in steep cuts along the alignment. Existing steep slopes along the trail alignment in this geologic unit should be considered highly susceptible to shallow landslides and debris flows.

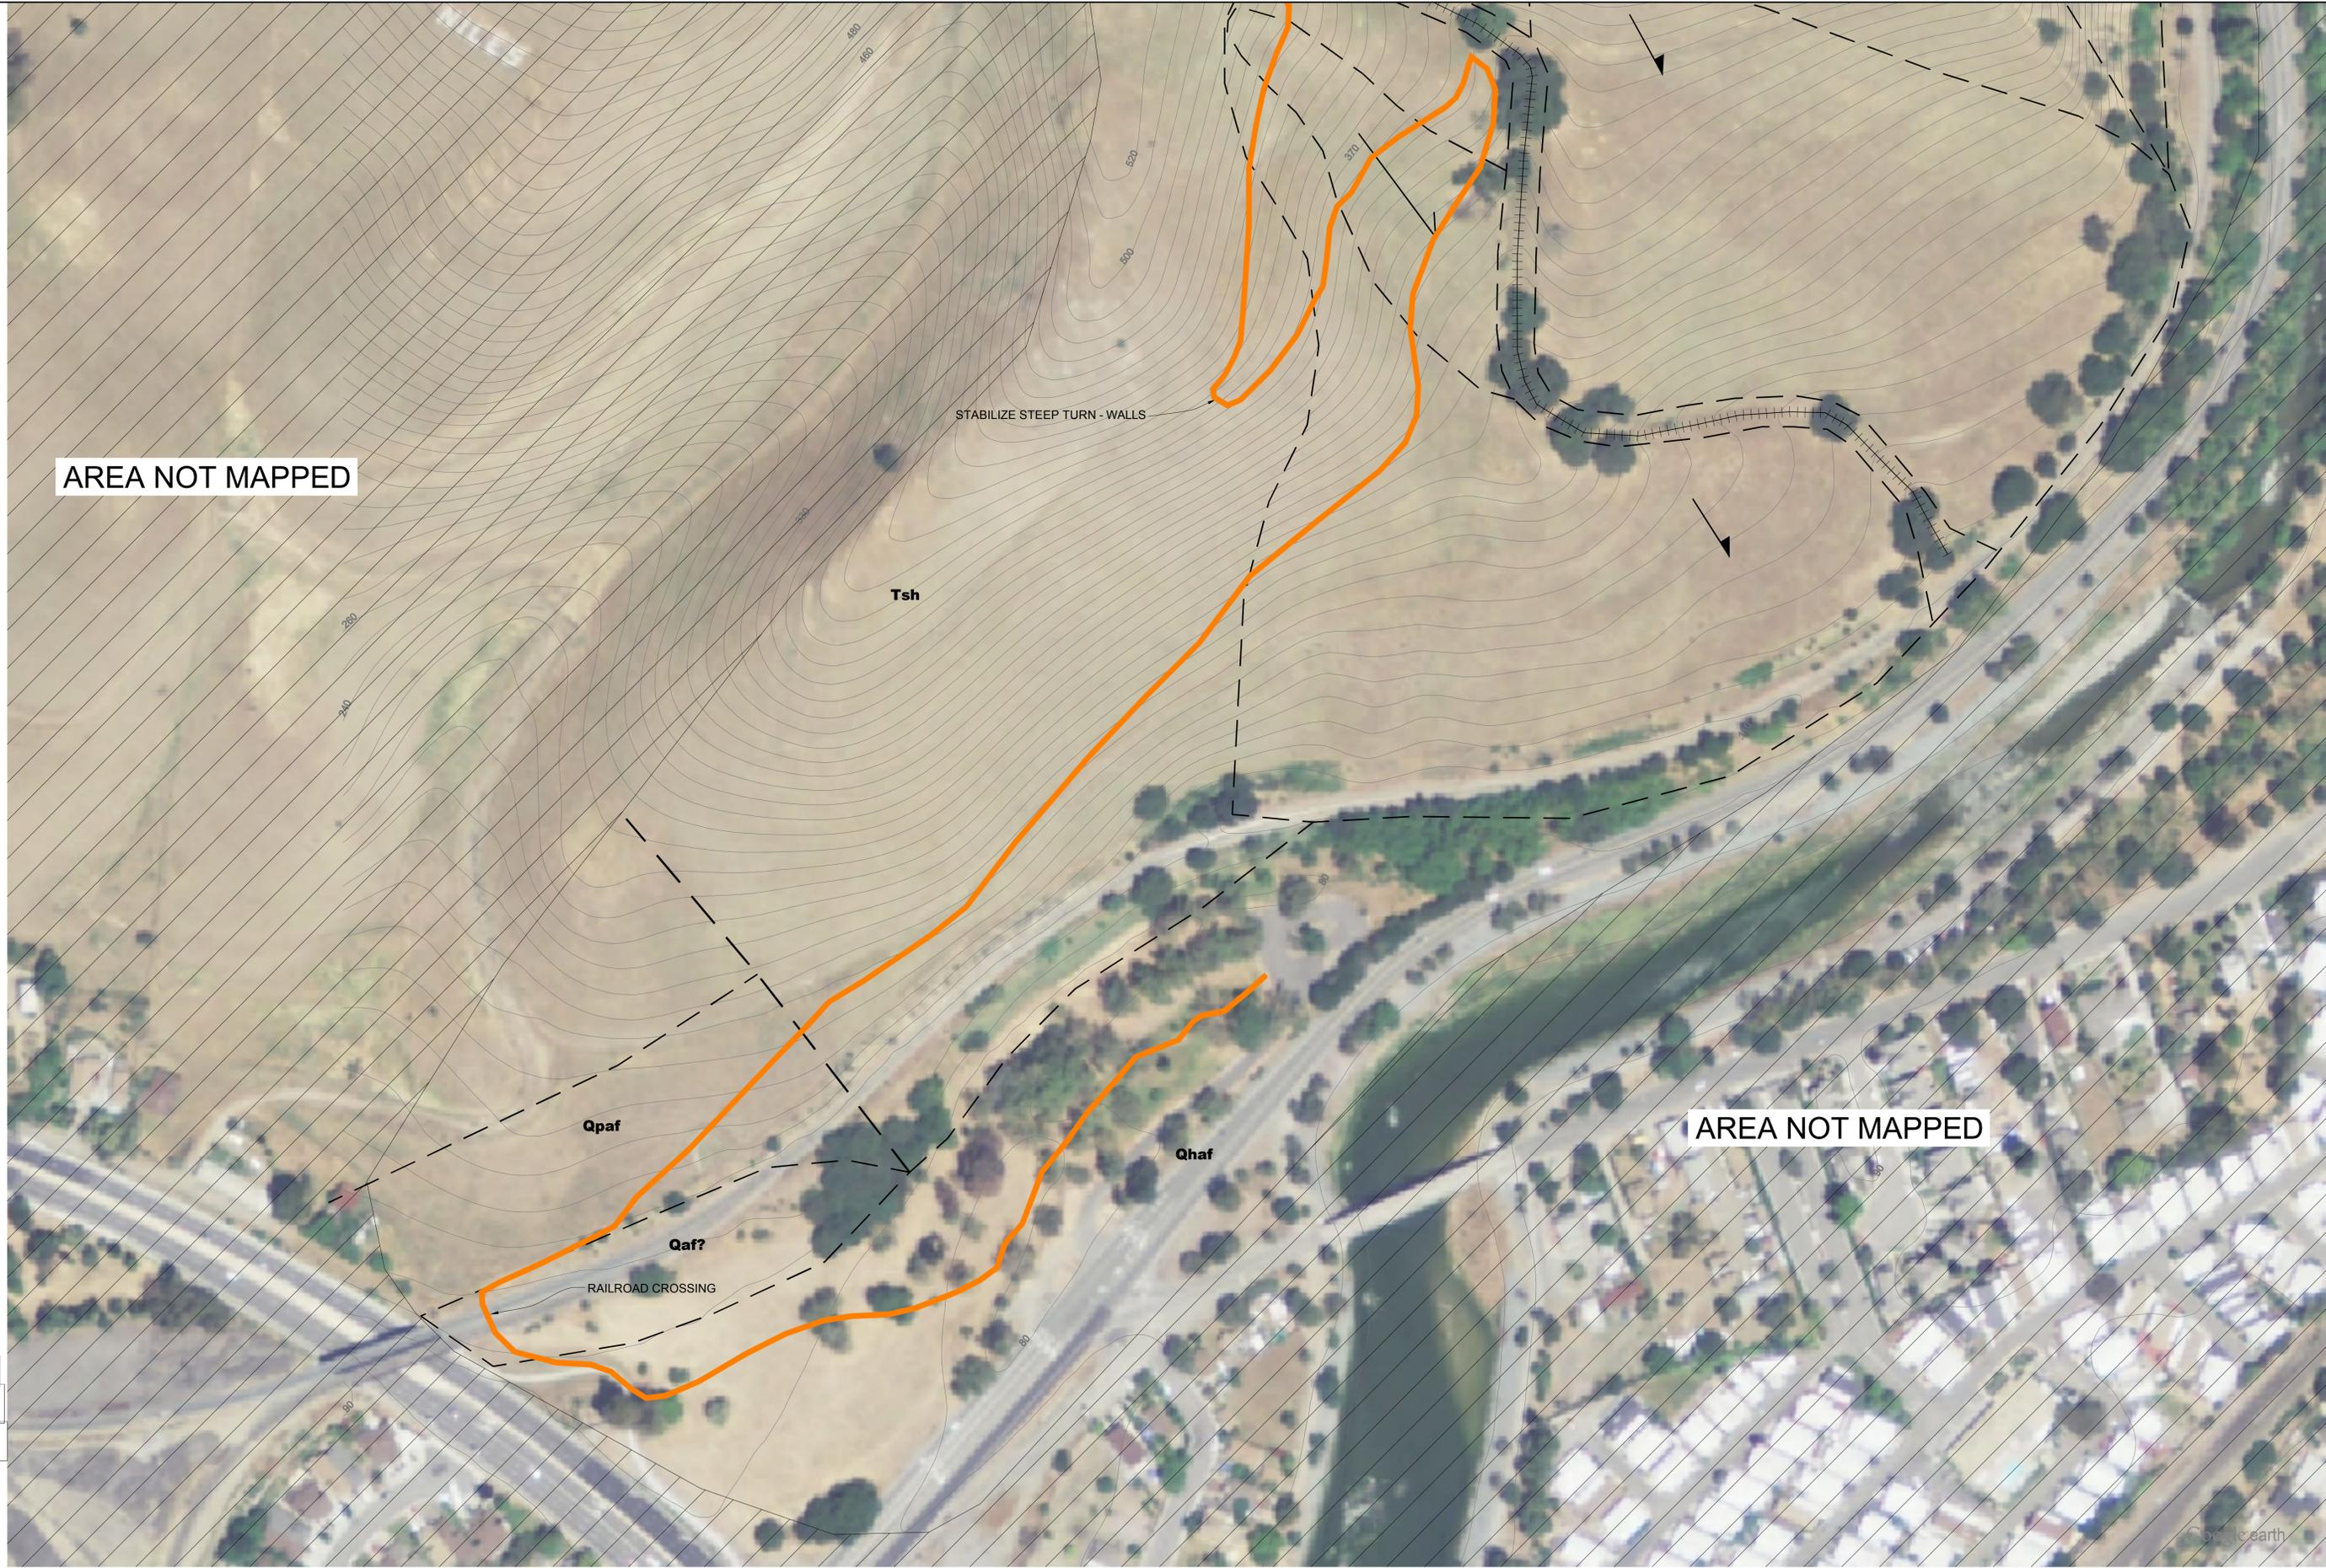
STABILIZE STEEP TURN - WALLS
