Appendix G (Part 1)

PHASE I ASSESSMENT

MEMORANDUM

Date: April 20, 2016
To: Ms. Suzanne Wilson, Senior Planner - Trails EBRPD
From: Mr. Brett Bardsley, P.G. and Mr. Michael Leacox, C.E.G.
Subject: Hazardous Waste Memorandum – San Francisco Bay Trail at Point Molate

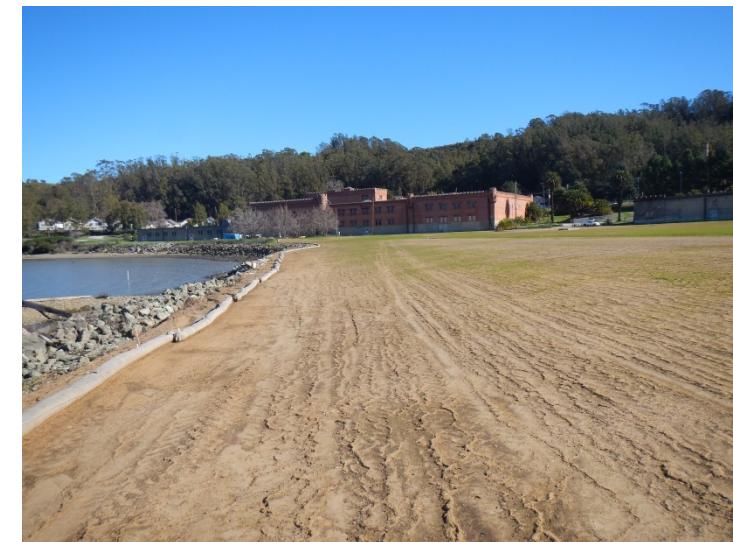
Photo 4. View facing northeast at IR Site 3 (Former Treatment Ponds). Remedial excavation activities were recently completed in this area (February 1, 2016; Map 15).

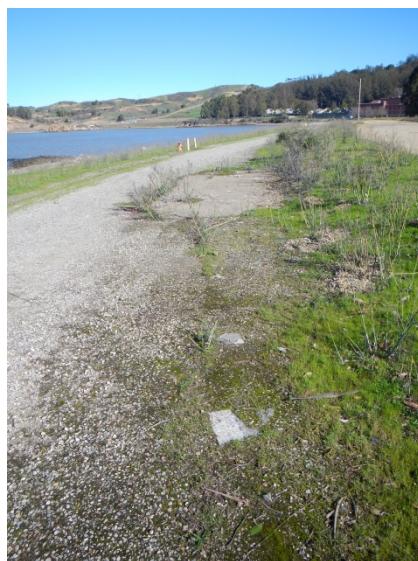
Photo 7. View facing northeast at the northwest portion of IR Site 4 (Drum Lot 1). Visible in the central portion of the photograph are what appear to be asbestos roofing shingles (February 1, 2016; Map 13).

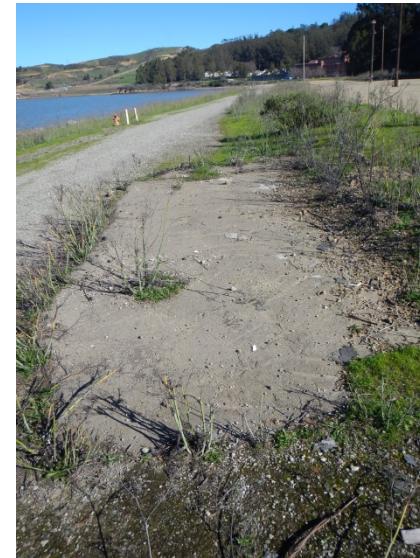
Photo 6. View facing northeast at the northwest portion of IR Site 4 (Drum Lot 1). What appeared to be asbestos roofing shingles were observed in this area (February 1, 2016; Map 13).

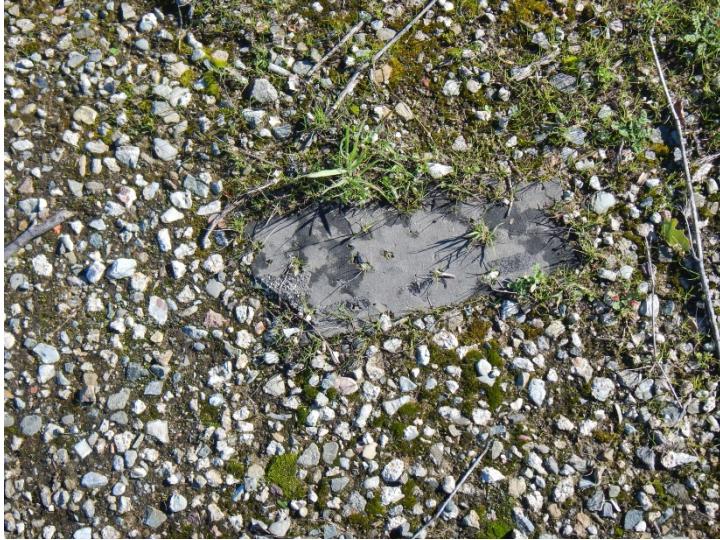
Photo 9. View of what appears to be an asbestos roofing shingle at IR Site 4 (Drum Lot 1) (February 1, 2016; Map 13)).

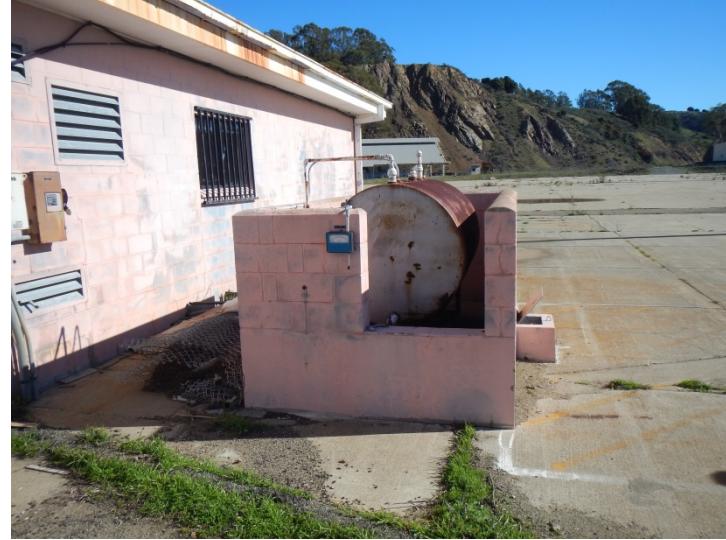
Photo 10. View facing east at drum located adjacent to Operations Buildings (February 1, 2016; Map 13).

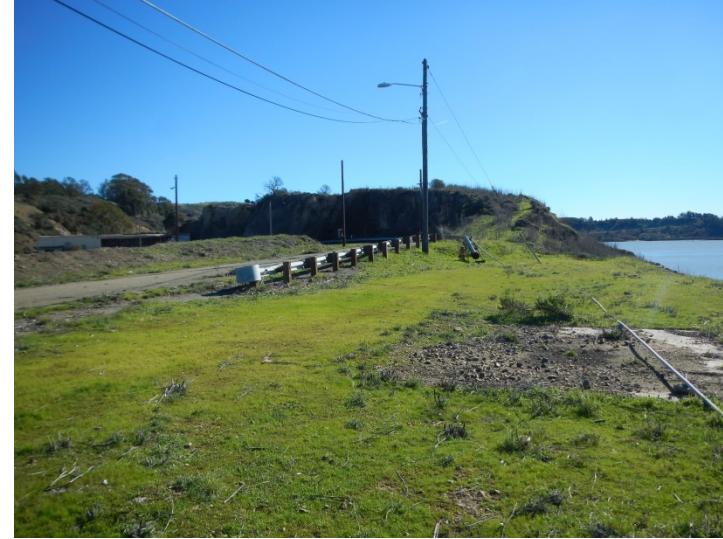
Photo 14. View facing south at southern portion of IR Site 4 (Drum Lot 1). Former petroleum pipeline is visible in the top central portion of photograph (February 1, 2016; Map 13).

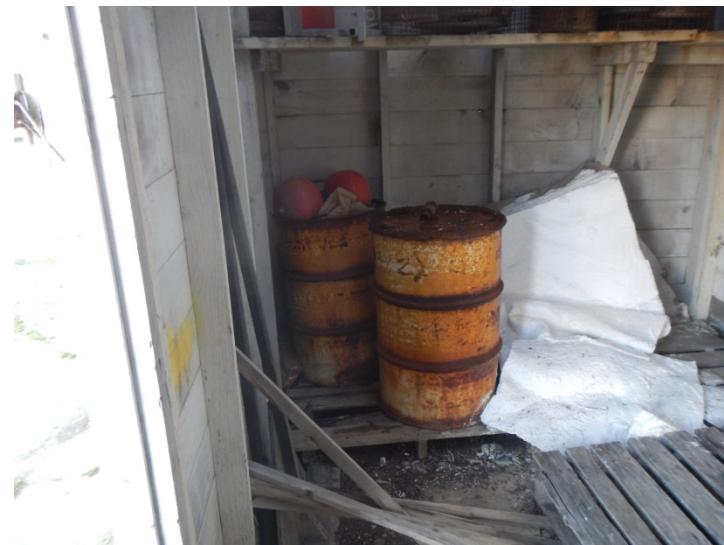
Photo 18. View of drums located in Building 69 Pump House located in the southeast portion of IR Site 4 (Drum Lot 1) (February 1, 2016; Map 13).

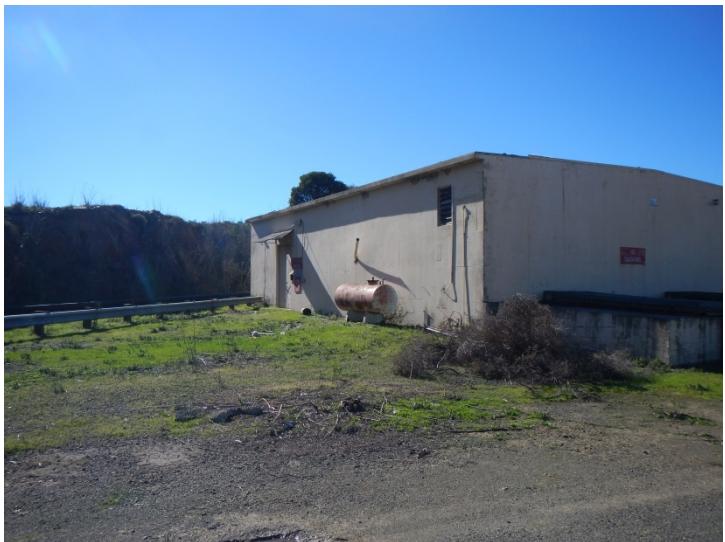
Photo 19. View facing southwest at AST located on the east side of Building 69 Pump House (February 1, 2016; Map 13).

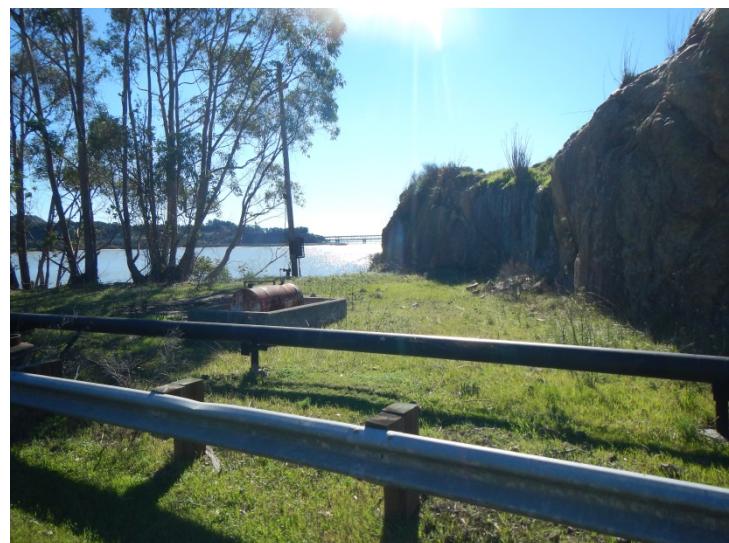
Photo 20. View facing south at AST located to the east of IR Site 4 (Drum Lot 1) (February 1, 2016; Map 13).

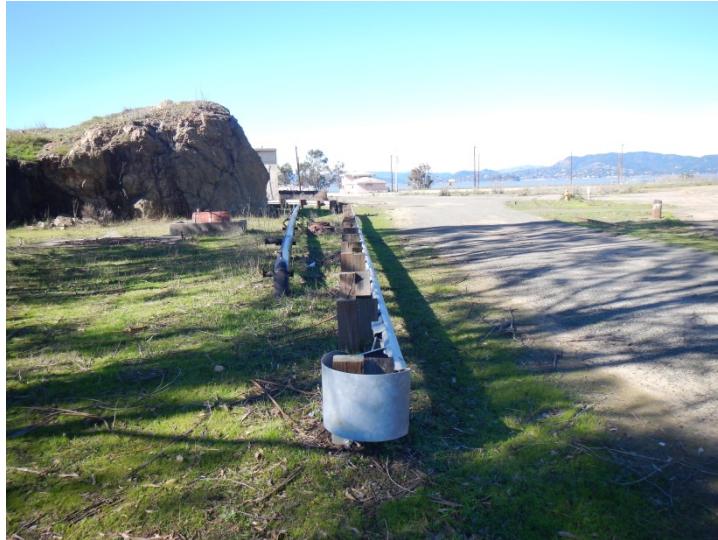
Photo 21. View facing west at former petroleum pipeline (February 1, 2016; Map 12).

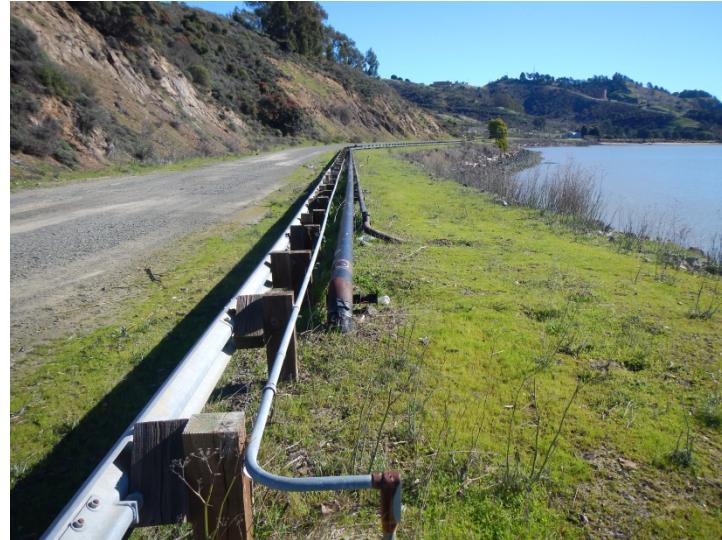
Photo 22. View facing east at former aboveground petroleum pipeline. Pipeline appears to contain asbestos coating (February 1, 2016; Map 12).

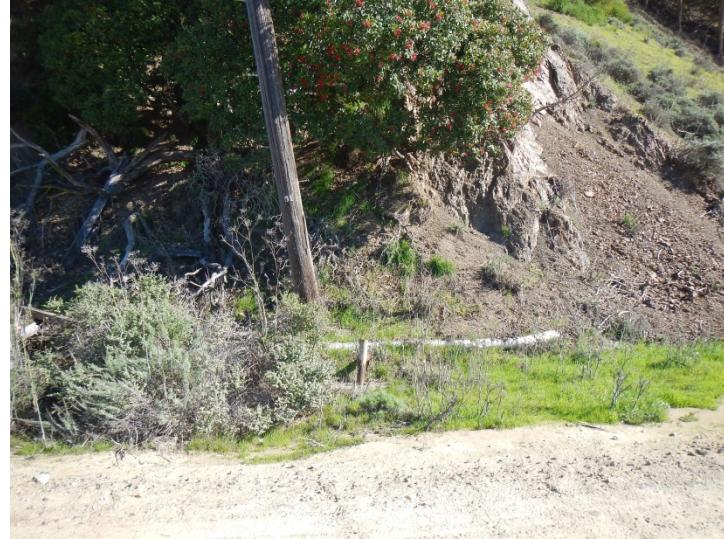
Photo 30. View facing east at surface raveling in the vicinity of OU1 Upland Cap Section TO-101 (June 18, 2014).

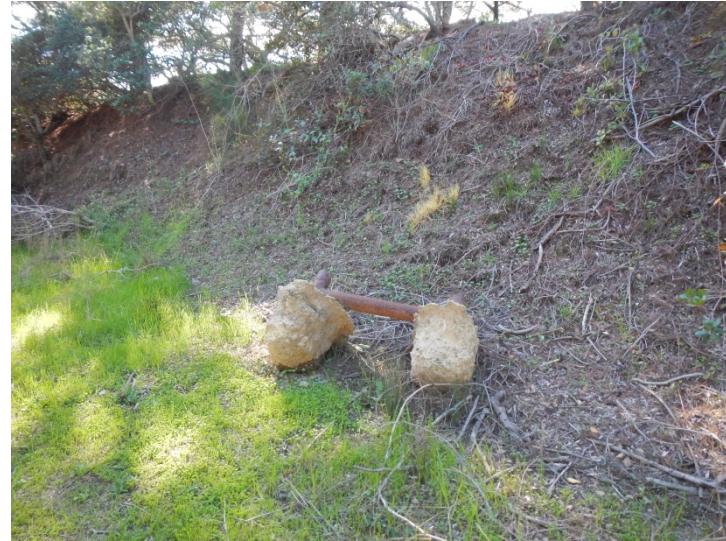
Photo 38. View of abandoned pipeline supports in the southern portion of Segment B (February 1, 2016; Map 7).

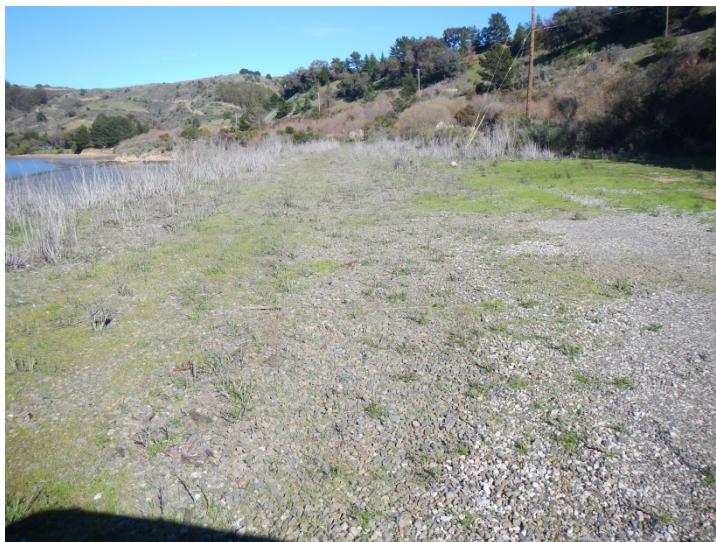
Photo 39. View facing north at the northern portion of Castro Point. The darker rocks in the central portion of the photograph may be ballast related to the former railroad corridor (February 1, 2016; Map 4).
