**FORMER RODDY RANCH GOLF COURSE  
HABITAT RESTORATION AND  
PUBLIC ACCESS PLAN**

**Existing Conditions Report - Attachments**

## ENGE0. 2020. SUMMARY OF GEOTECHNICAL CONSTRAINTS. RODDY RANCH GOLF COURSE – ANTIOCH, CA.

**SUMMARY OF GEOTECHNICAL CONSTRAINTS**

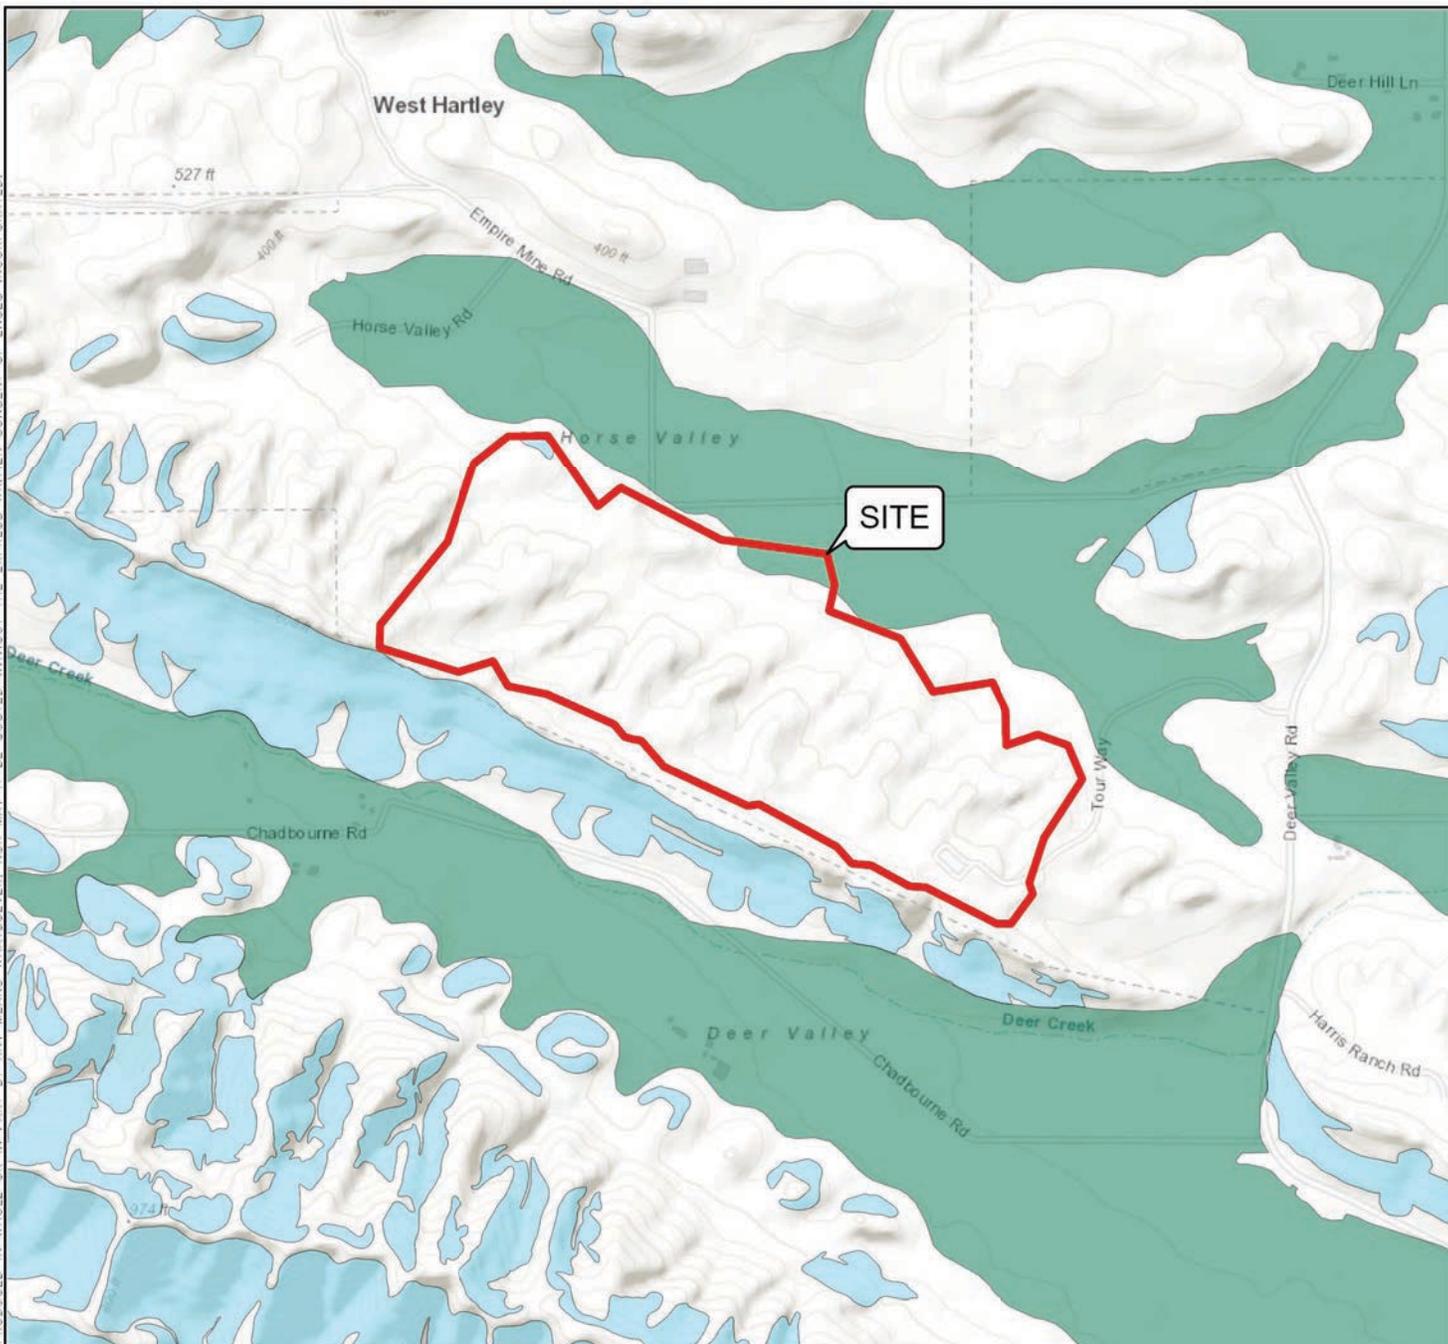
FIGURE NO.  
4

- EARTHQUAKE-INDUCED LANDSLIDE ZONES**  
 AREAS WHERE PREVIOUS OCCURENCE OF LANDSLIDE MOVEMENT, OR LOCAL TOPOGRAPHIC, GEOLOGICAL, GEOTECHNICAL AND SUBSURFACE WATER CONDITIONS INDICATE A POTENTIAL FOR PERMANENT GROUND DISPLACEMENTS SUCH THAT MITIGATION AS DEFINED IN PUBLIC RESOURCES CODE SECTION 2693(C) WOULD BE REQUIRED.

- LIQUEFACTION ZONE**  
 AREAS WHERE HISTORICAL OCCURENCE OF LIQUEFACTION, OR LOCAL GEOLOGICAL, GEOTECHNICAL AND GROUND WATER CONDITIONS INDICATE A POTENTIAL L FOR PERMANENT GROUND DISPLACEMENTS SUCH THAT MITIGATION AS DEFINED IN PUBLIC RESOURCES CODE SECTION 2693(C) WOULD BE REQUIRED

**SEISMIC HAZARDS ZONE MAP**  
 RODDY RANCH GOLF COURSE  
 ANTIOCH, CALIFORNIA

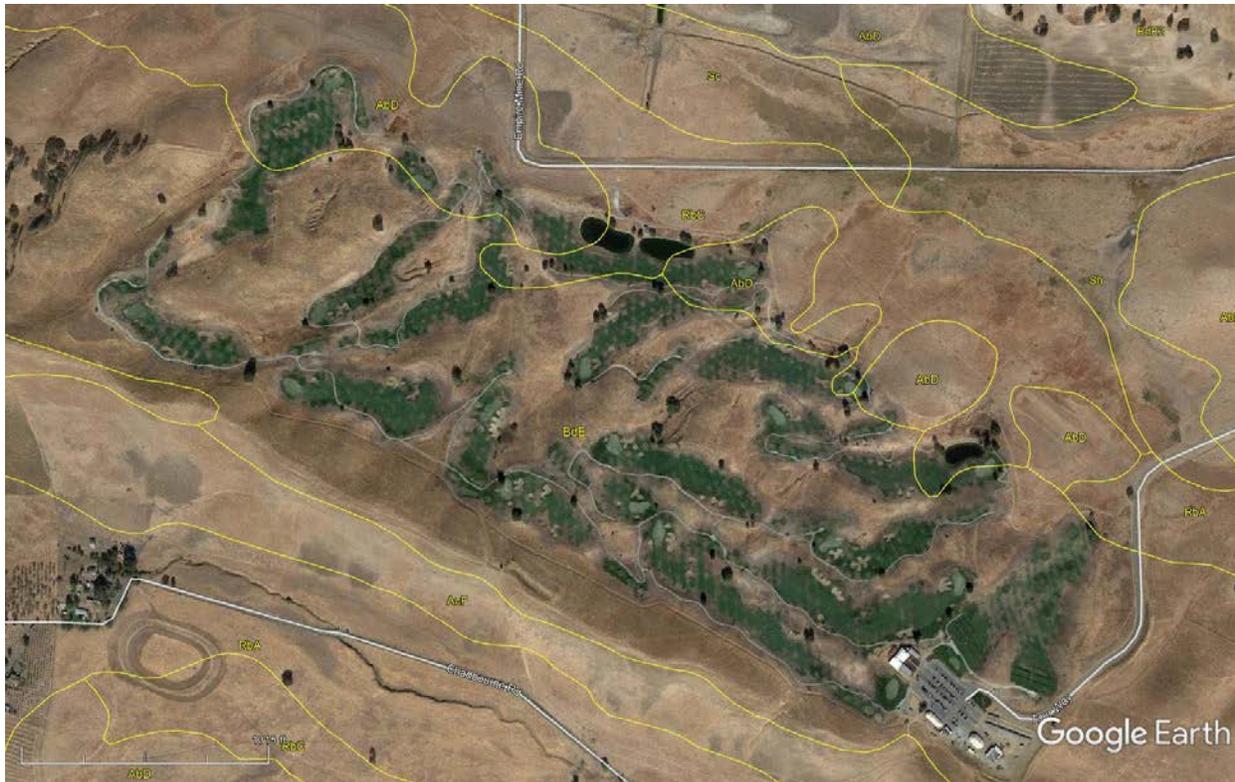
Figure 1. Soils of Roddy Ranch (Google Earth image from 10/30/2015).

The site is on a north-northeast facing ridge of soft sandstone that slopes down from a ridge on the south-west side of the project area to a series of low hills and toe slopes on the north-northeast side. Soils on the higher sandstone areas are mapped (Contra Costa soil survey, 1977) as Briones loamy sand (mapping unit BdE, Figure 1, Google Earth). A narrow area along the north boundary of the project is underlain by shale and soft, fine-grained sandstones. Soils at these low hill and toe slope positions are mapped as Altamont clay (AbD) on the lower smooth rolling hills or Rincon clay loam (RbC) soils in small drainageways. The lowest landforms are benches on alluvial fill above local drainages (Horse Creek) and are mapped as Rincon clay loam (RbC) (Figure 1. Soils of Roddy Ranch).

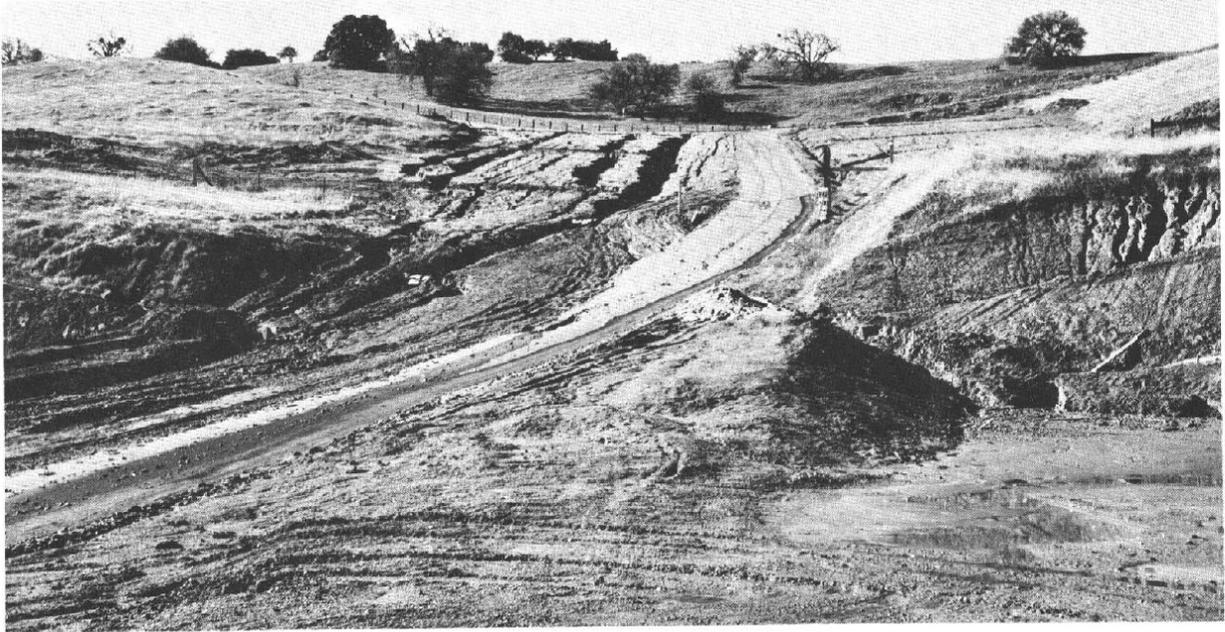
**Figure 3.—Erosion in this area of unprotected Briones soils during construction contributes to sedimentation of the streams and reservoir downslope.**

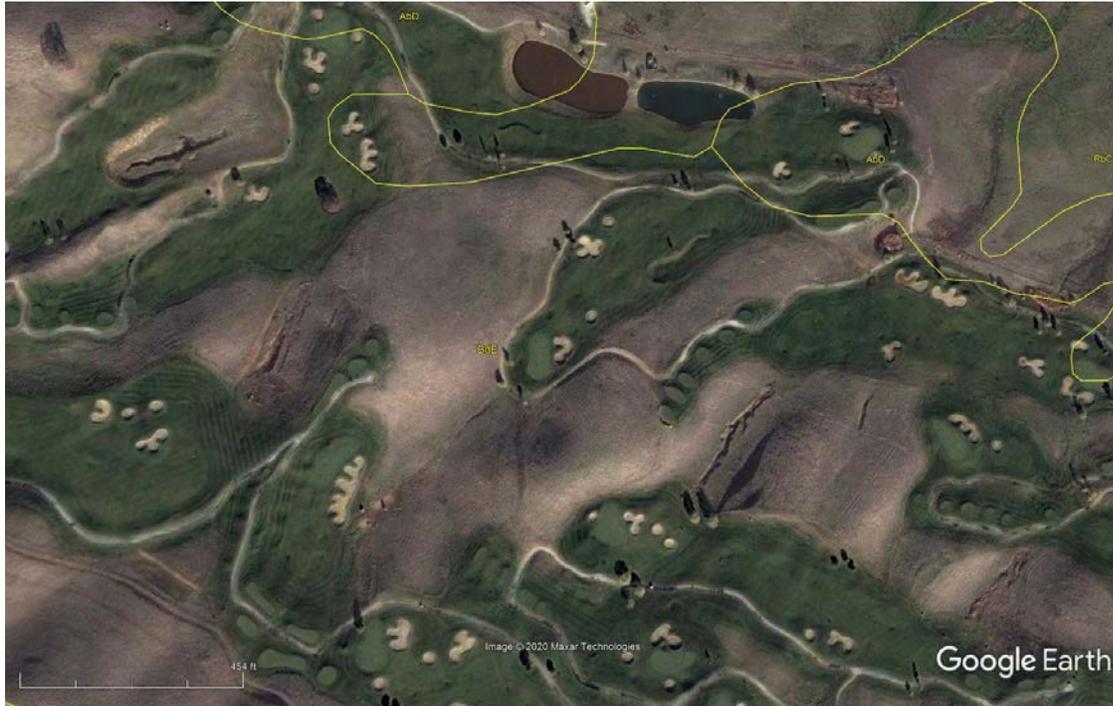
Figure 3. Overhead view of golf course soon after construction showing multiple gullies from increased runoff following grading and soil impacts. Image date: 12/13/2003.

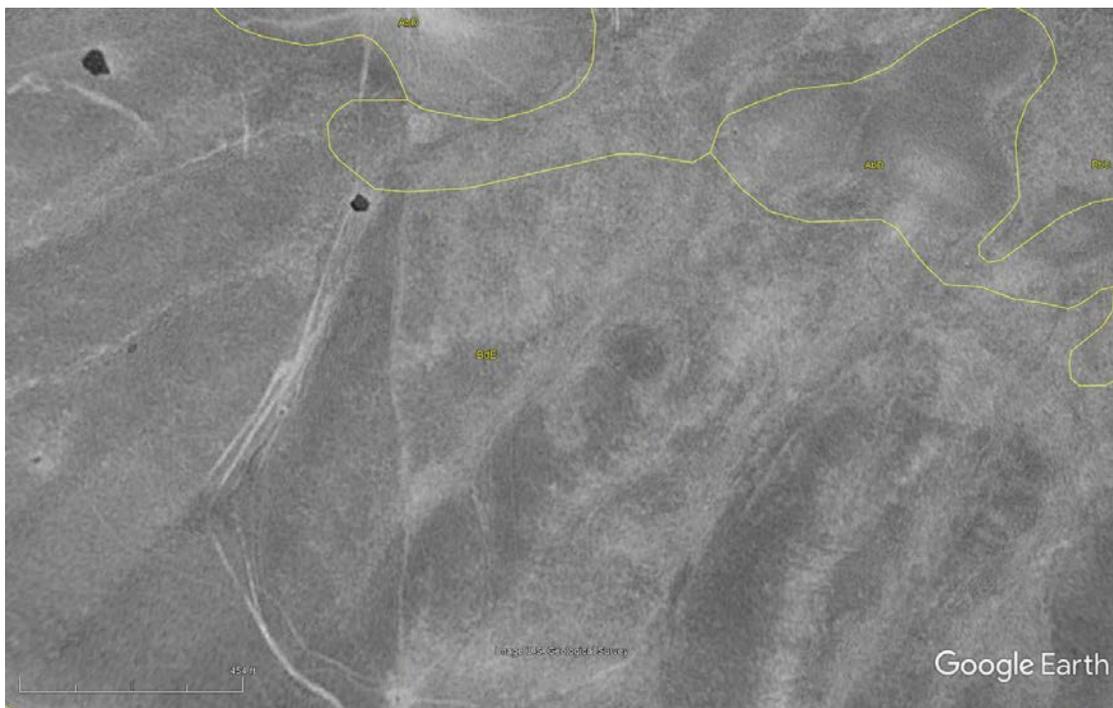
Figure 4. Overhead view of same site as Figure 3 but before golf course grading and construction. Gullies are smaller or have grassed over. Image date: 6/11/1993.

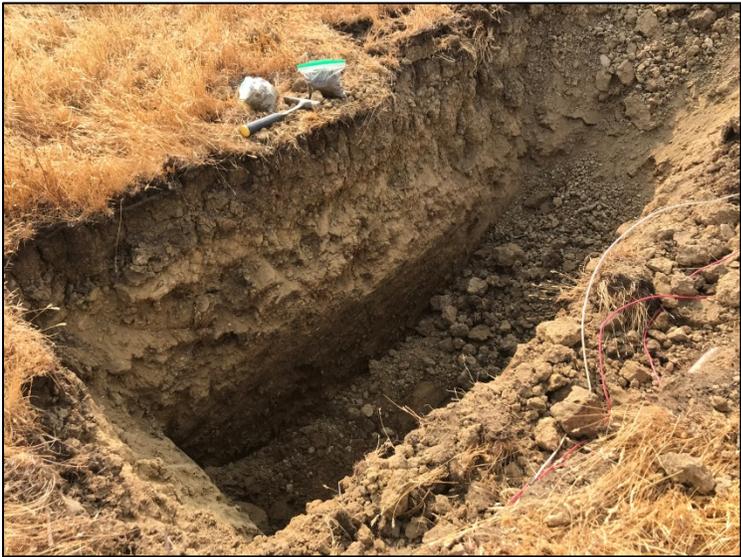
Pit G6

Photos of soil pits showing clay subsoil horizons

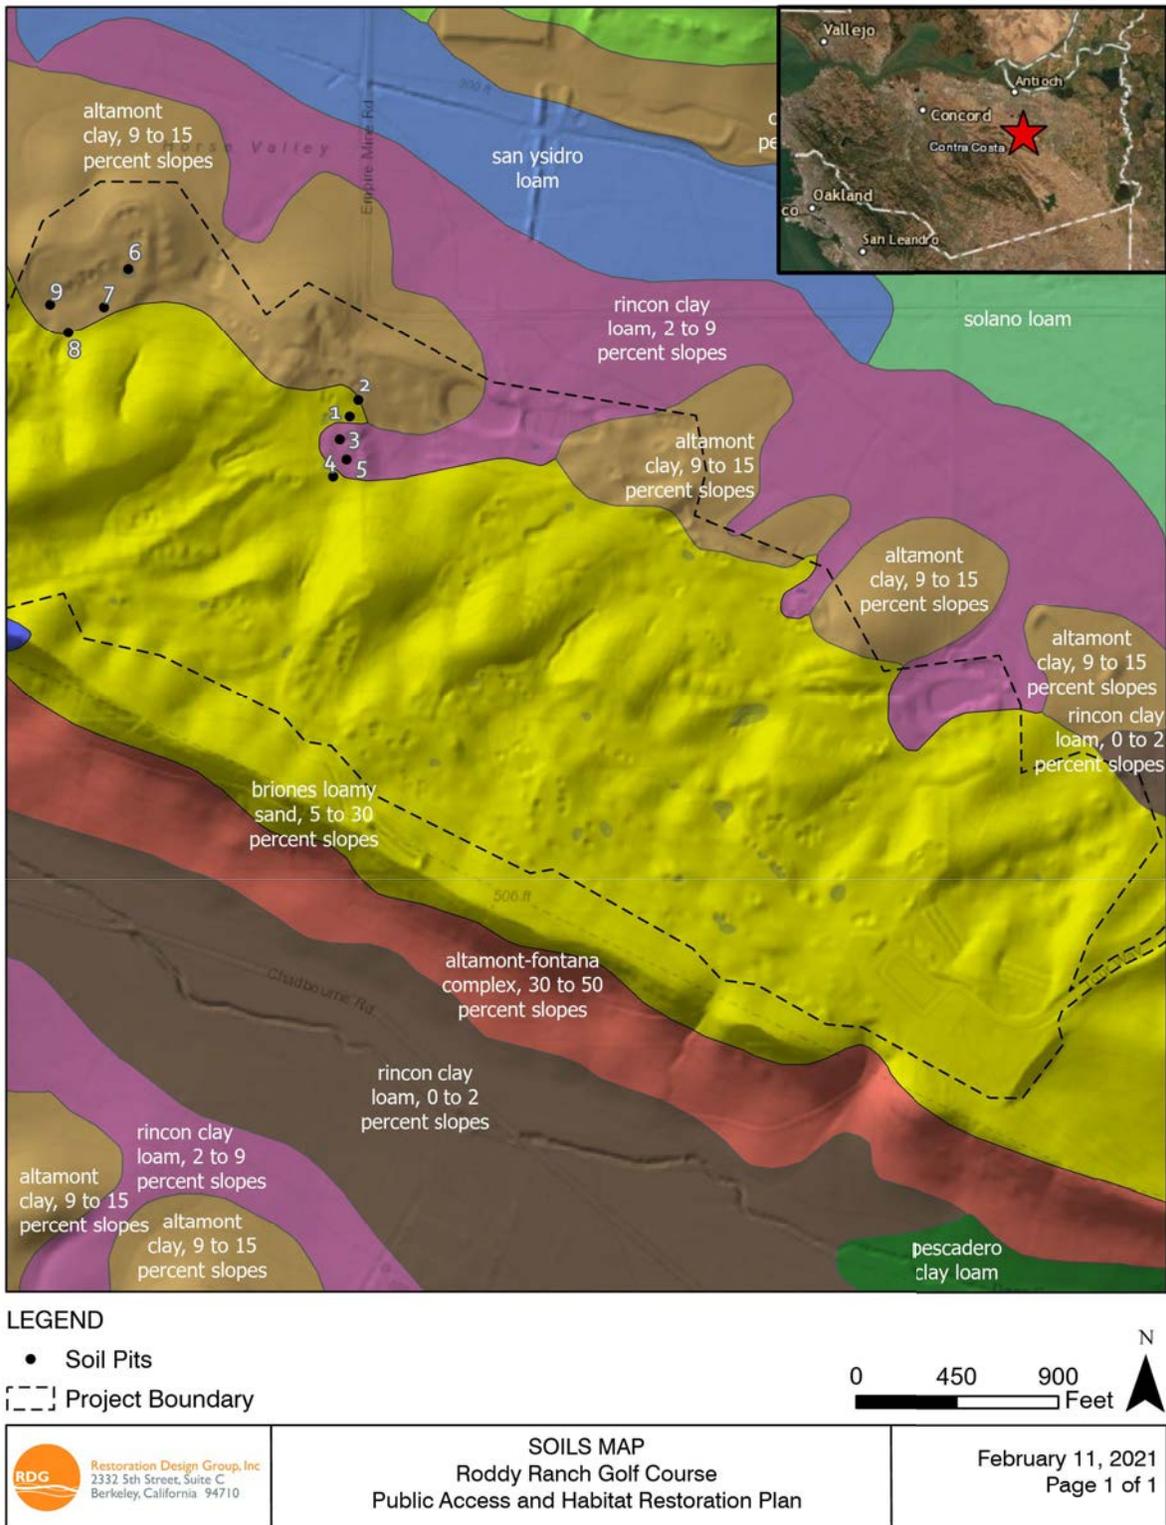
Figure 1. Locations of soil pits in potential wetlands construction areas (RDG graphic).

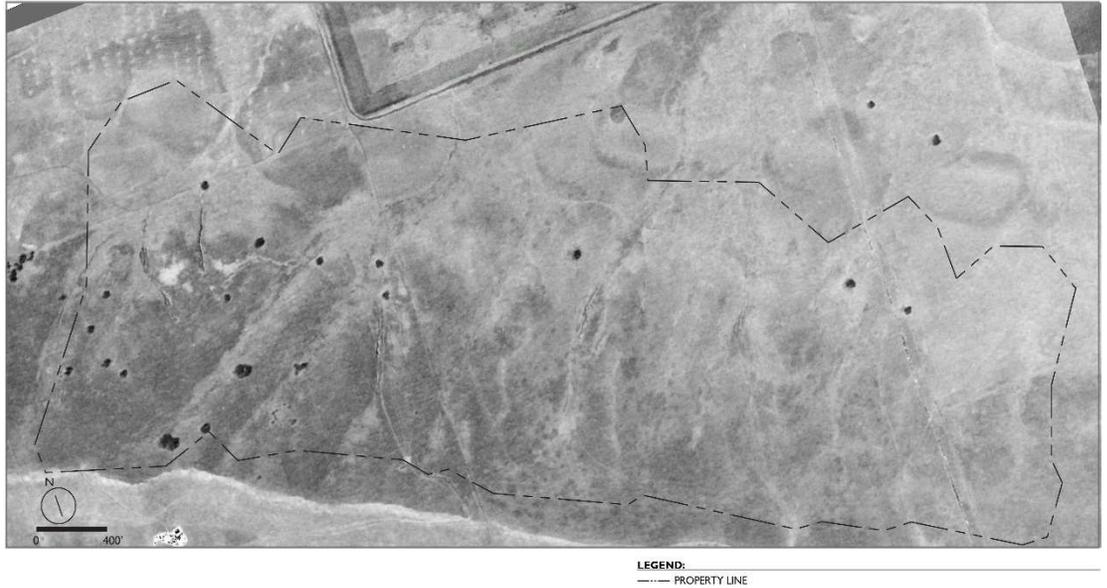
Figure 2: 1939 Aerial

The project site drains a north facing slope that was historically grasslands (Figure 2). The hillslope is divided into a series of small drainages between 20.5 and 58.4 acres. Each drainage descends approximately 260-ft in elevation across approximately 2,100-ft. Most of the drainages occur as sheet flow at the top and bottom of the site, with a short portion of defined channel occurring at the base of the steeper hillslopes. Each drainage flows north off site in a network of grassy swales and shallow depressions that collect along the shoulder of Empire Mine Road north of the site.

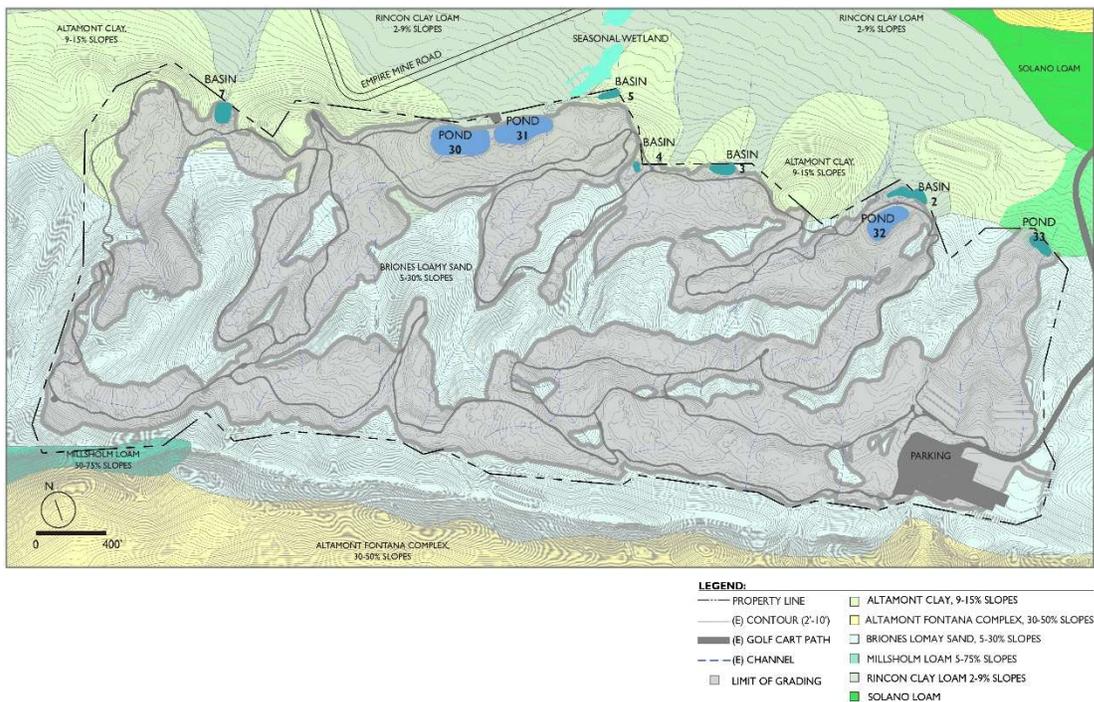
Figure 5: Soils and Grading Footprint

The following figure below shows the golf course limits of grading and the NRCS Soil Survey with Briones Loamy Sand composing the majority of the site and Altamont Clay and Rincon Clay Loam occupying the lower margins (north edge) of the site.

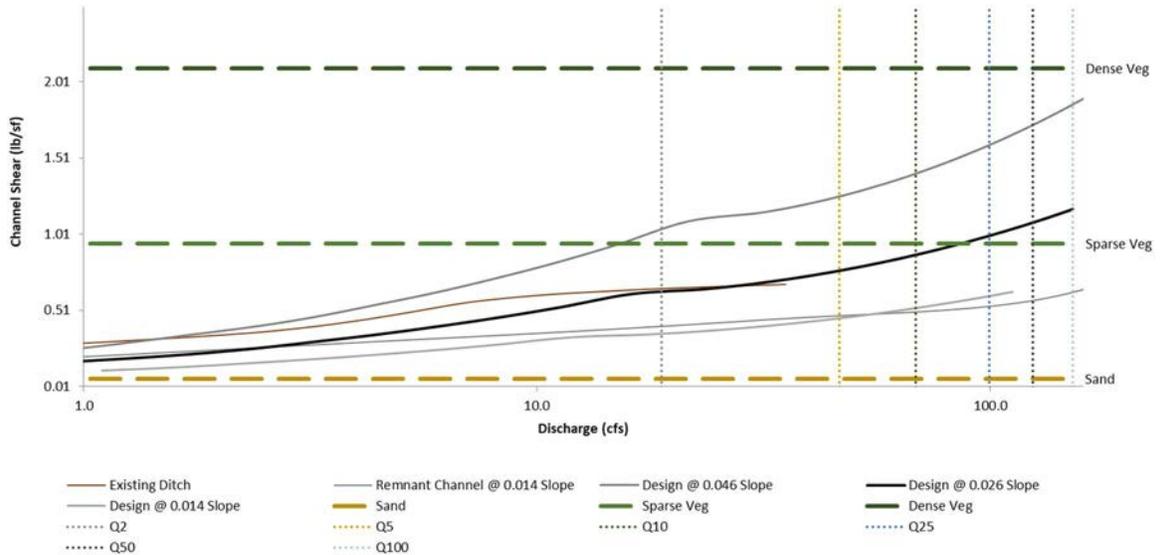
Figure 8: Channel Stability Investigation at Horse Valley. Channel stability thresholds were investigated for a wide range of channel geometries, discharges, slopes, and materials.

For the work developing similar channels in the adjacent Horse Valley, RDG assessed the relationship between channel slope and vegetation cover on channel stability, among other metrics (Restoration Design Group, 2016). This work revealed the degree to which converting sparse vegetation to dense vegetation increased a given channels ability to withstand a greater flow, or alternatively, allowed a given flow to be suitably conveyed down a steeper channel.

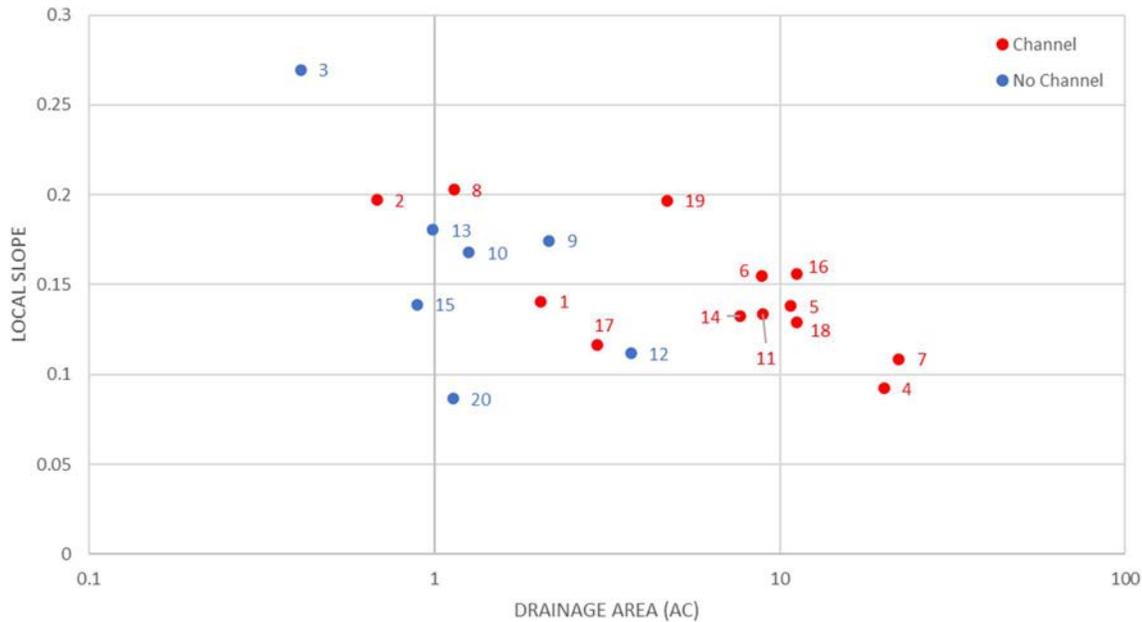
Figure 9: Slope and Drainage Area as a function of Channel Formation on Roddy Ranch Golf Course

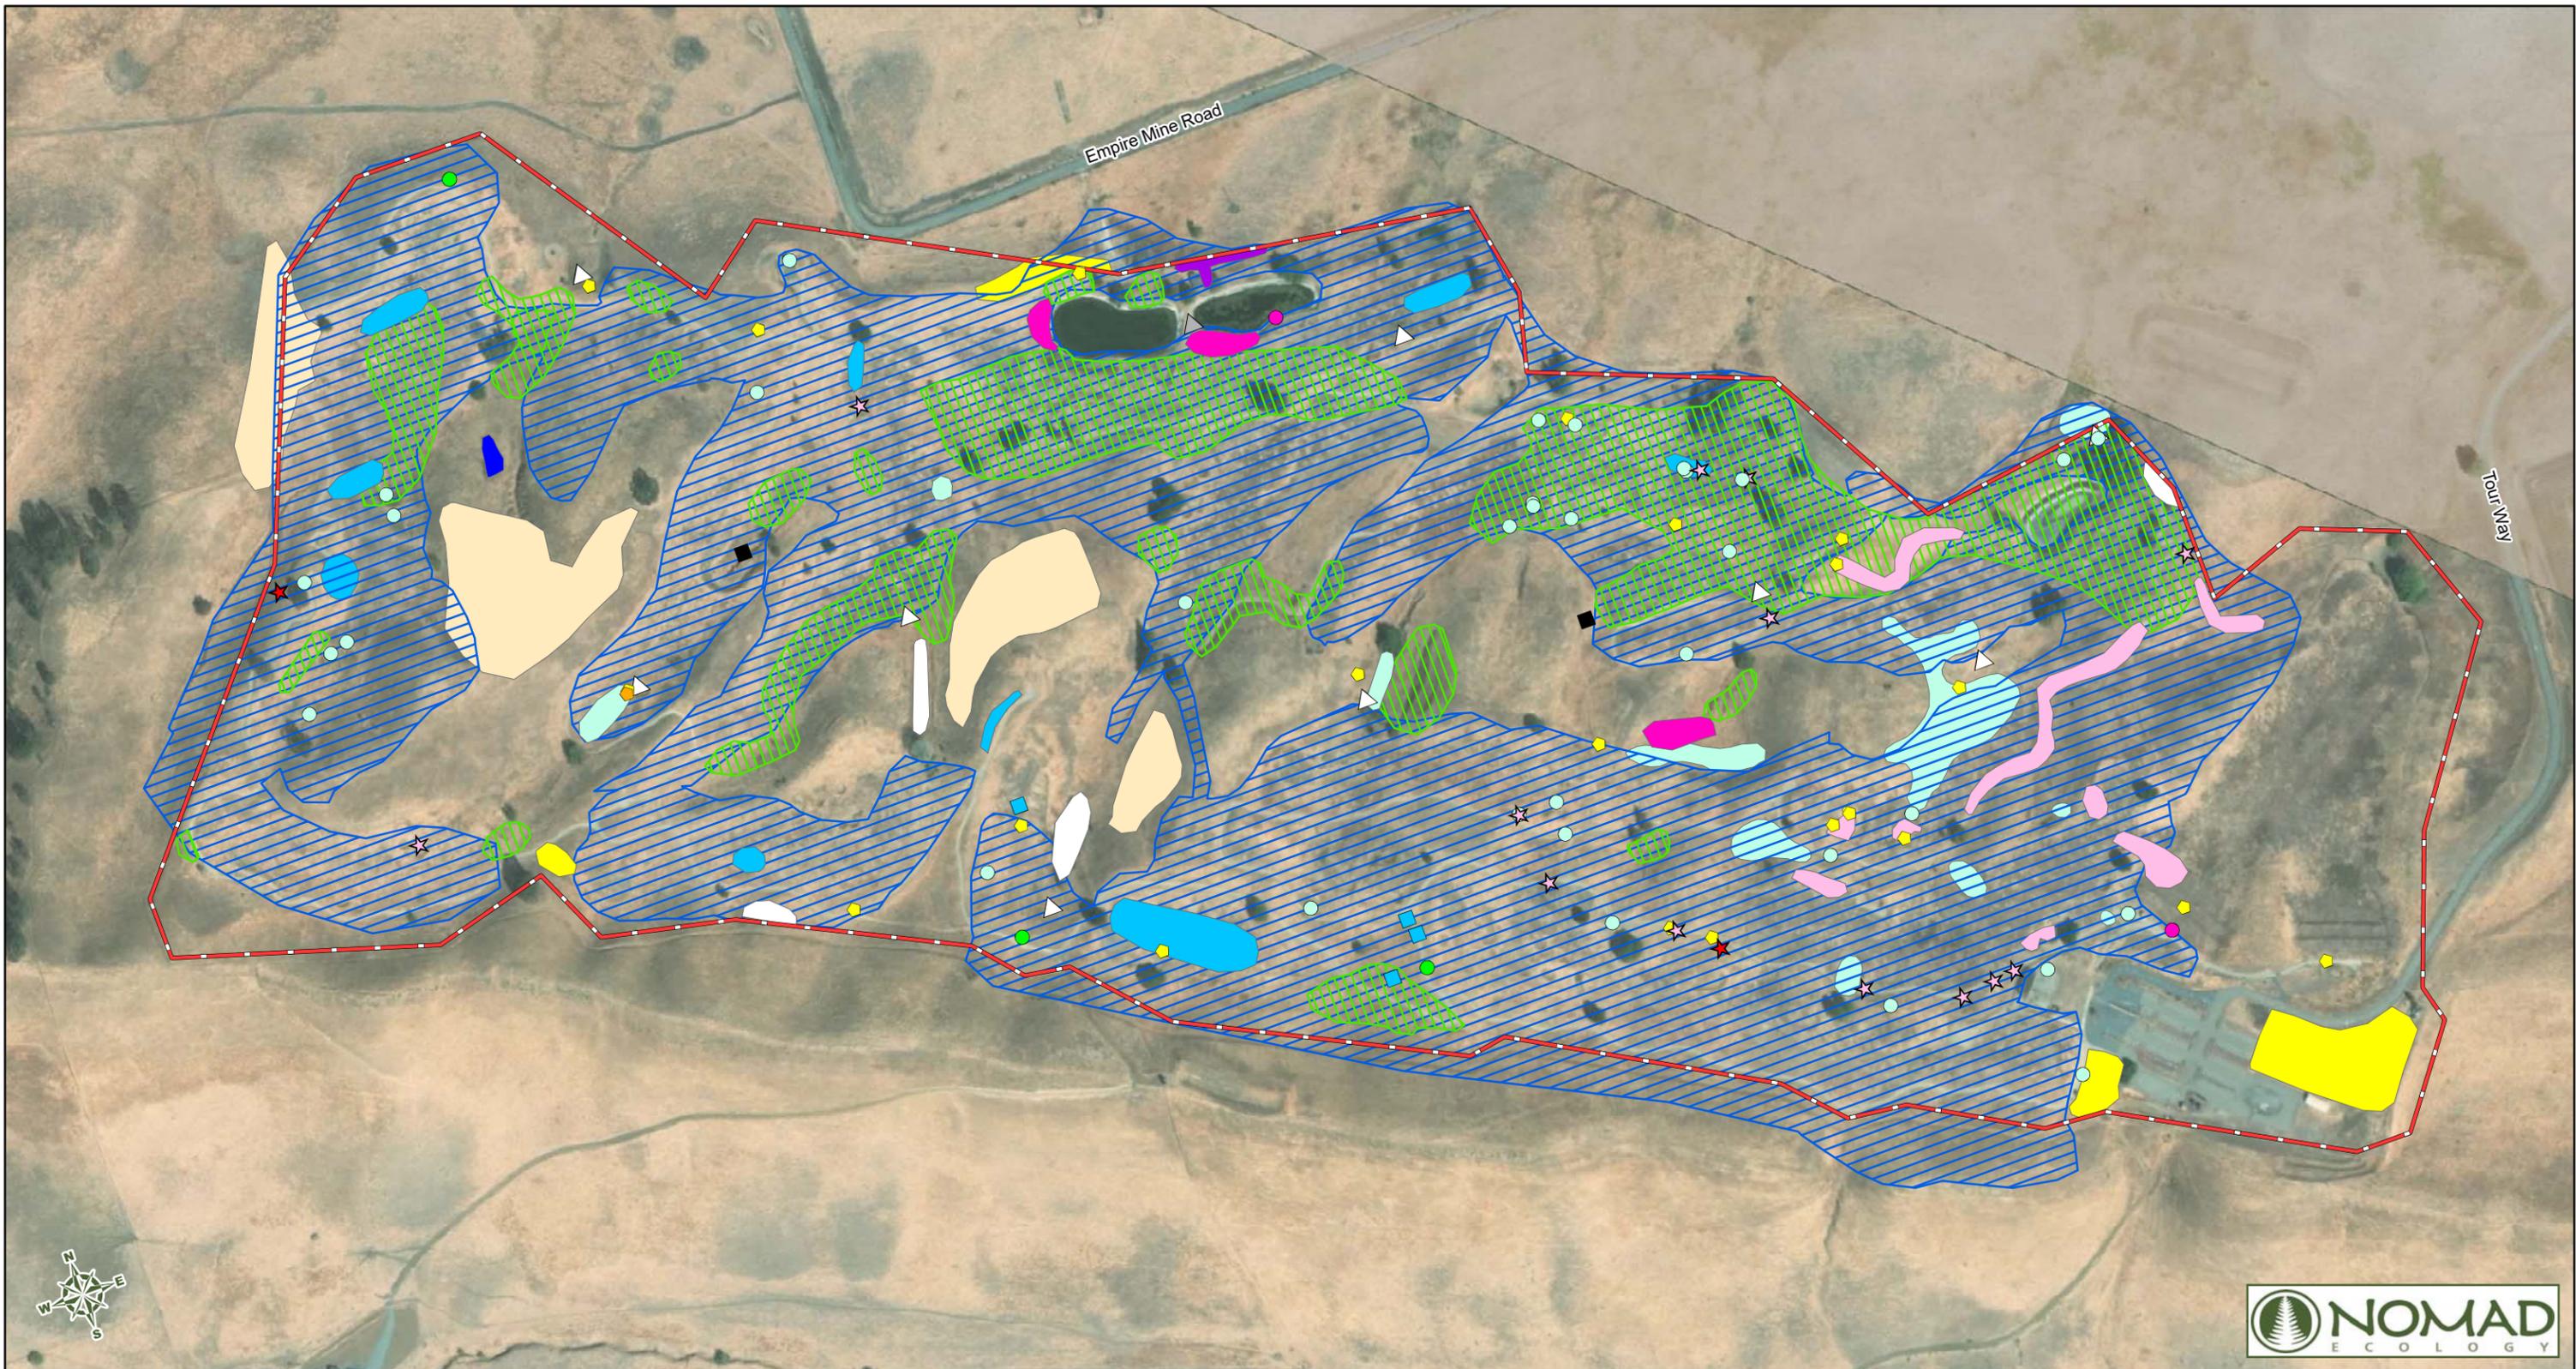
**Figure 5**  
**Invasive Weeds in the Study Area**  
 Former Roddy Ranch Golf Course Habitat Restoration and Public Access Project  
 East Bay Regional Park District and East Contra Costa County Habitat Conservancy

Legend			
Study Area Boundary	perennial pepperweed	European olive	pampas grass*
<b>Invasive Weeds</b>	purple starthistle*	Russian thistle	perennial pepperweed
Italian thistle/slender flowered thistle*	stinkwort*	artichoke thistle*	stinkwort*
Russian thistle	tree of heaven	bull thistle	tocalote
bull thistle	wild radish	milk thistle	wild radish
medusahead grass	yellow starthistle*	yellow starthistle*	
milk thistle

Of the non-native plant species tracked by Cal-IPC and CDFA, 17 plant species observed within the study area are of concern (Table 8 and Figure 5). These species have a ranking of Limited, Moderate or High by Cal-IPC. The Conservancy has been actively treating invasive weeds on site since 2018.

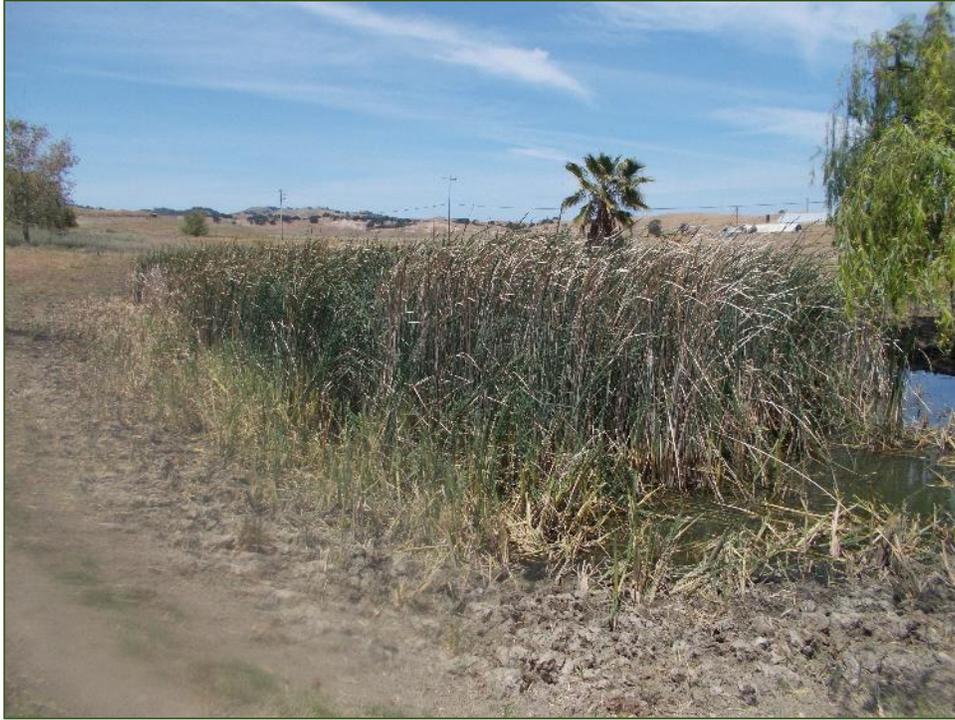
Photo 7. Photo 7. View of constructed water quality basin 5 which contains permanent wetland land cover. Facing northwest. May 10, 2018.

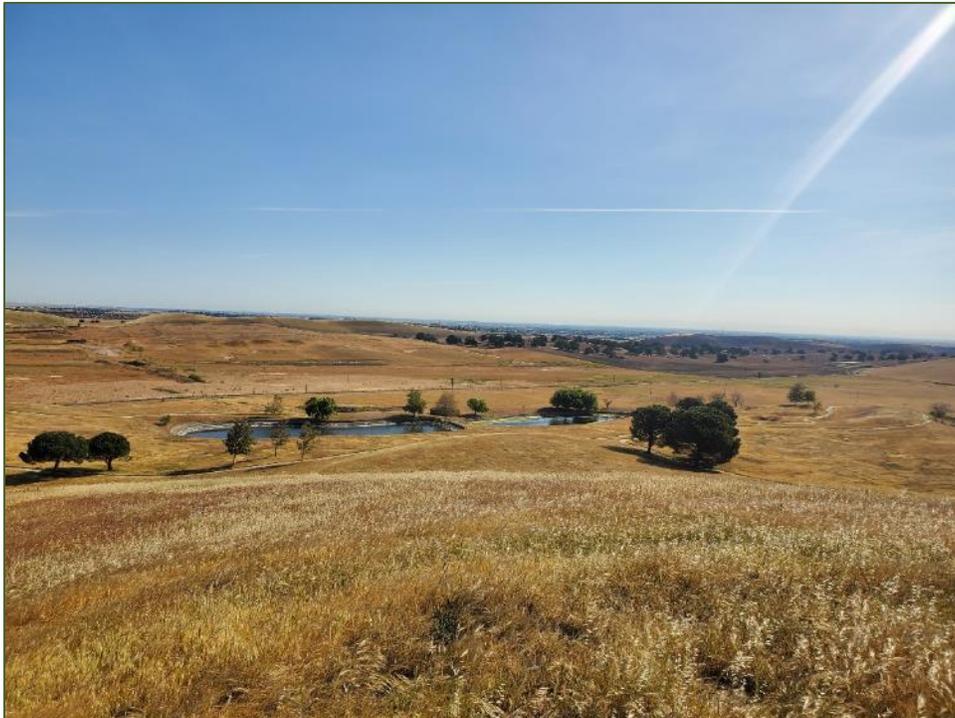
Photo 8. View of depnd030 and depnd031 which are constructed concrete-edged and plastic-lined irrigation ponds. Facing northeast. May 5, 2020.

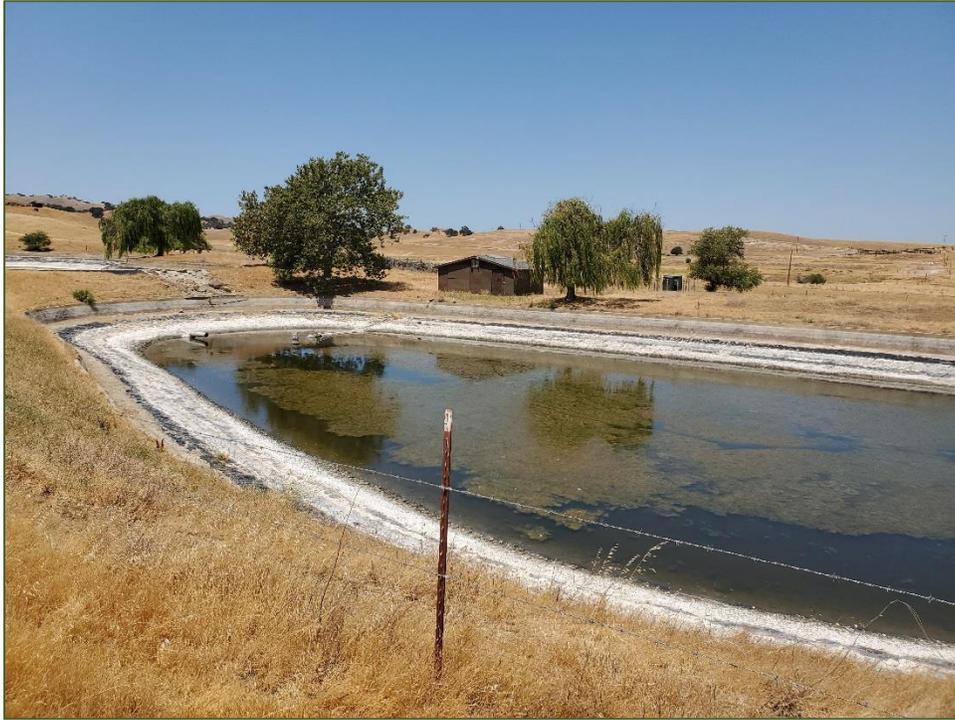
Photo 9. View of depnd031 which is a constructed concrete-edged and plastic-lined irrigation pond. The spillway from depnd030 is visible to the left of the photo. Facing northwest. May 5, 2020.

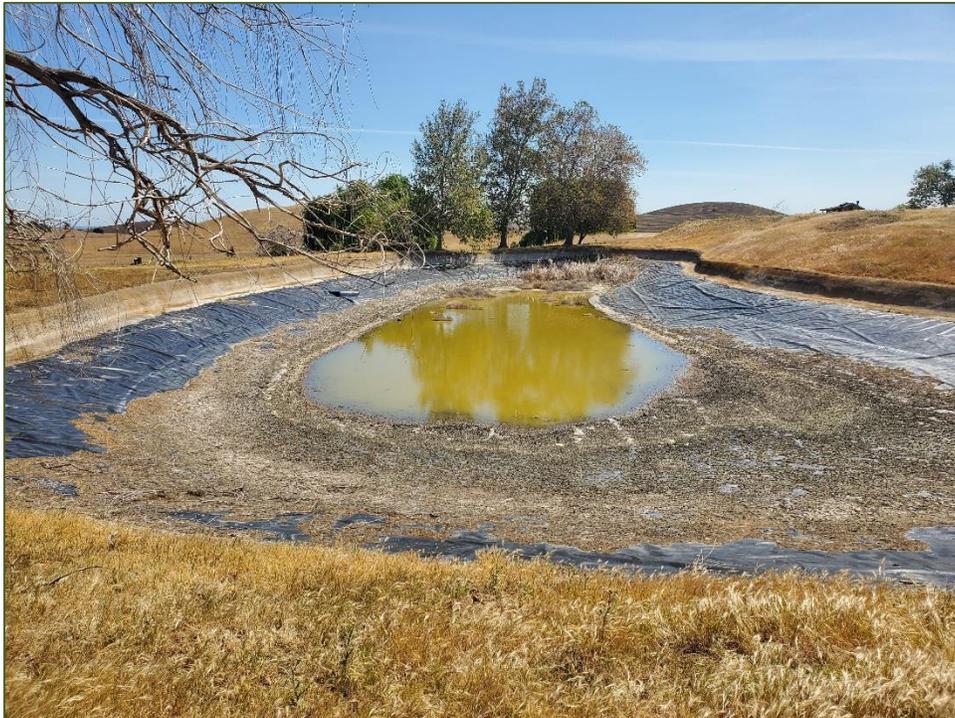
Photo 10. View of depnd032 which was a constructed concrete-edged and plastic-lined irrigation pond. A small patch of cattails was present. Facing east. February 4, 2020.

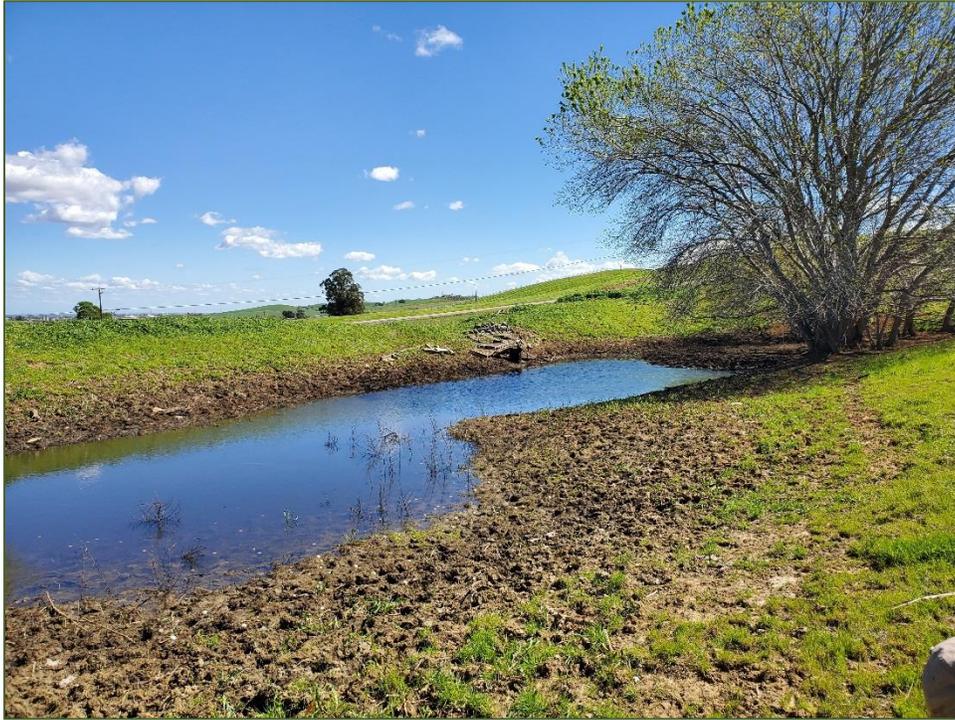
Photo 11. View of depnd033 which is a constructed earthen basin for golf course operation. Facing east.  
March 29, 2019.

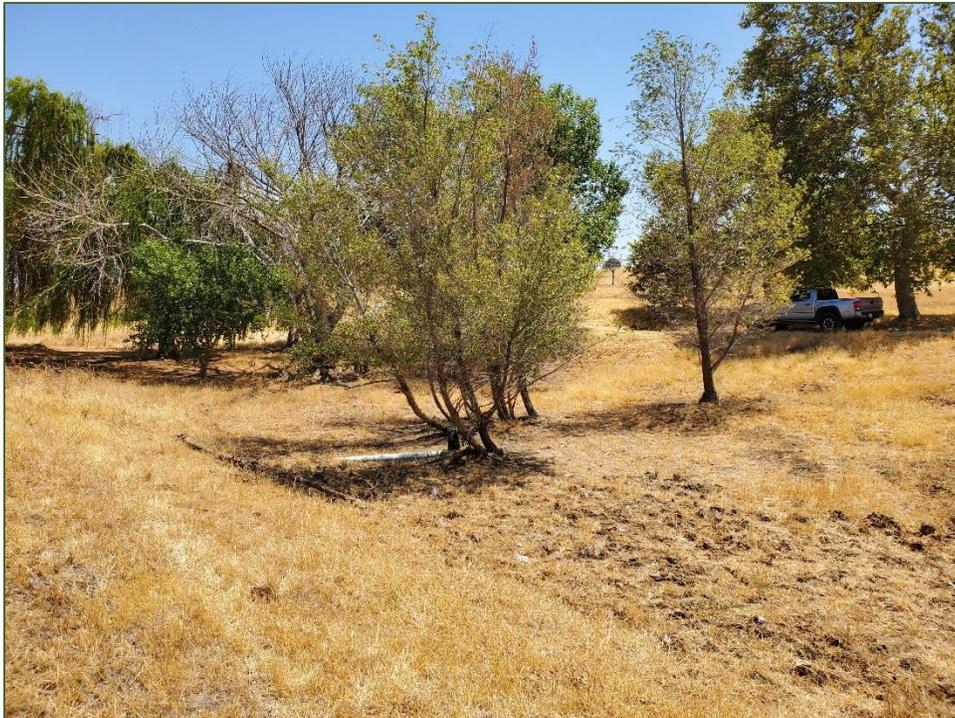
Photo 12. Basin 2 which is an earthen water quality basin constructed when the golf course was built. Facing east.  
July 27, 2020.

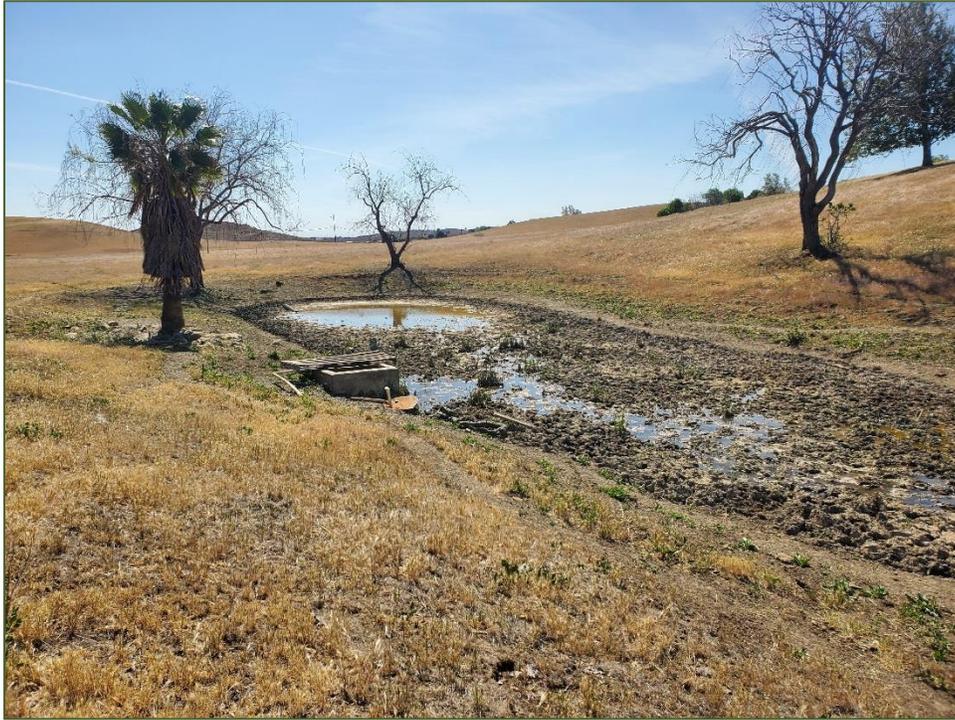
Photo 13. Basin 5 which is a earthen water quality basin constructed when the golf course was built. It is fed by a culvert from depnd031. Facing southeast. May 5, 2020.

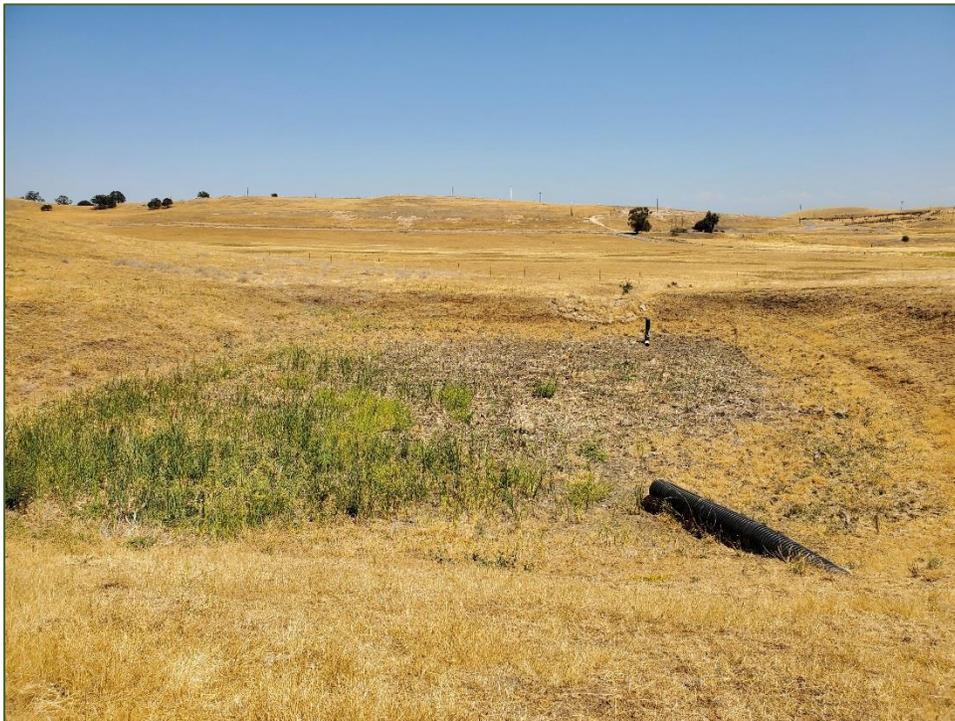
Photo 14. Basin 7 which is a earthen water quality basin constructed when the golf course was built. It is fed by the subsurface drainage system. Facing north. July 27, 2020.

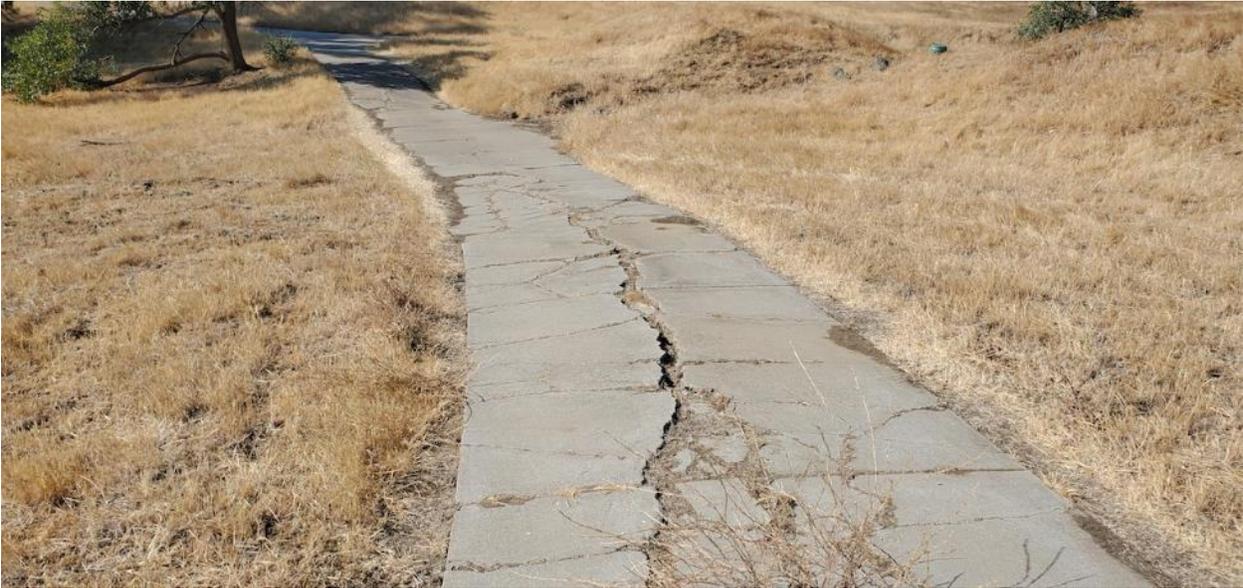
Photo 15. Concrete golf cart path with buckling concrete that may provide refugia for special status species. Facing south. July 16, 2020.

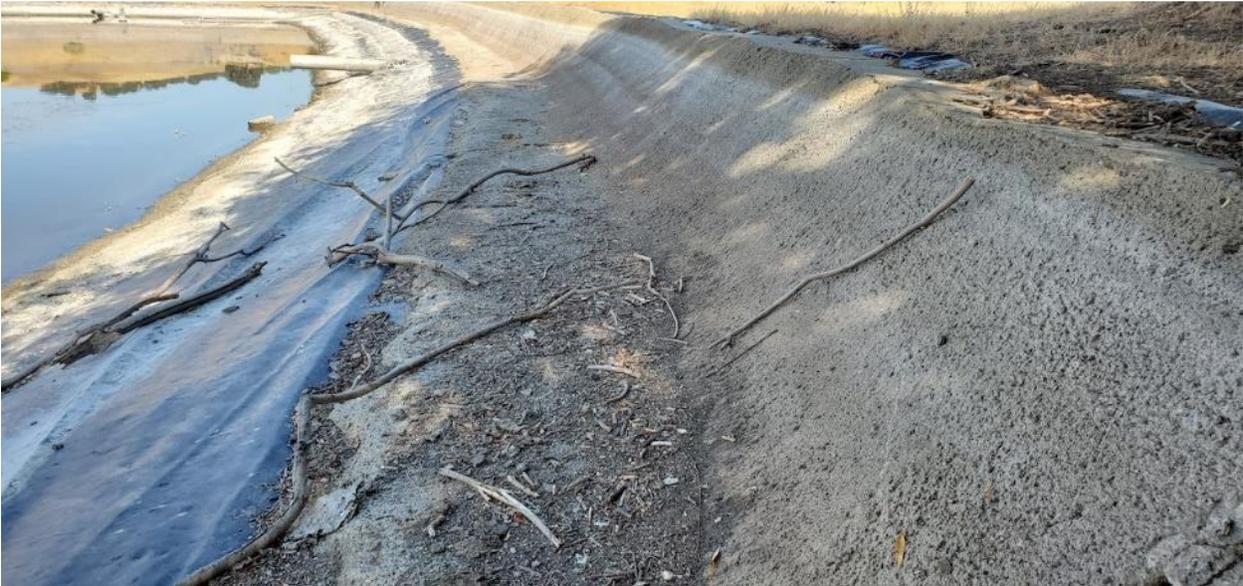
Photo 16. Edge of depnd031 showing vertical concrete bank (background) and short section of sloped bank (foreground) potentially allowing access for special status species. Facing west. July 16, 2020.
