**FORMER RODDY RANCH GOLF COURSE  
HABITAT RESTORATION AND  
PUBLIC ACCESS PLAN**

**Existing Conditions Report - Attachments**

## ENGE0. 2020. SUMMARY OF GEOTECHNICAL CONSTRAINTS. RODDY RANCH GOLF COURSE – ANTIOCH, CA.

**SUMMARY OF GEOTECHNICAL CONSTRAINTS**

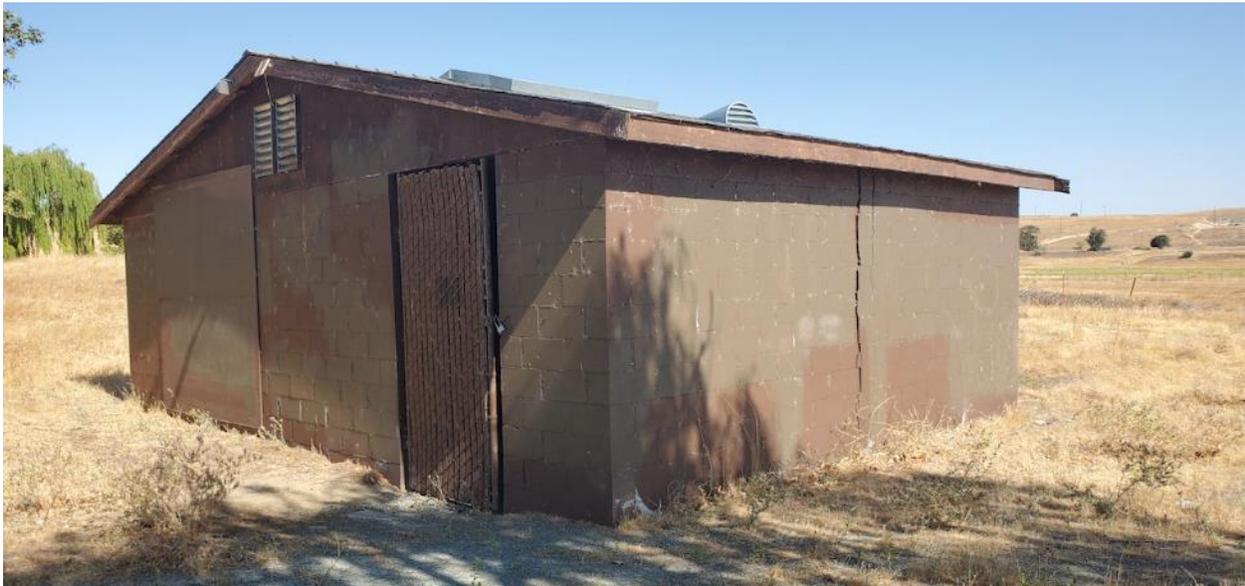
Photo 18. Pumphouse near depnd030 and depnd031 providing suitable habitat for rootsing bats. Facing northwest. July 16, 2020.

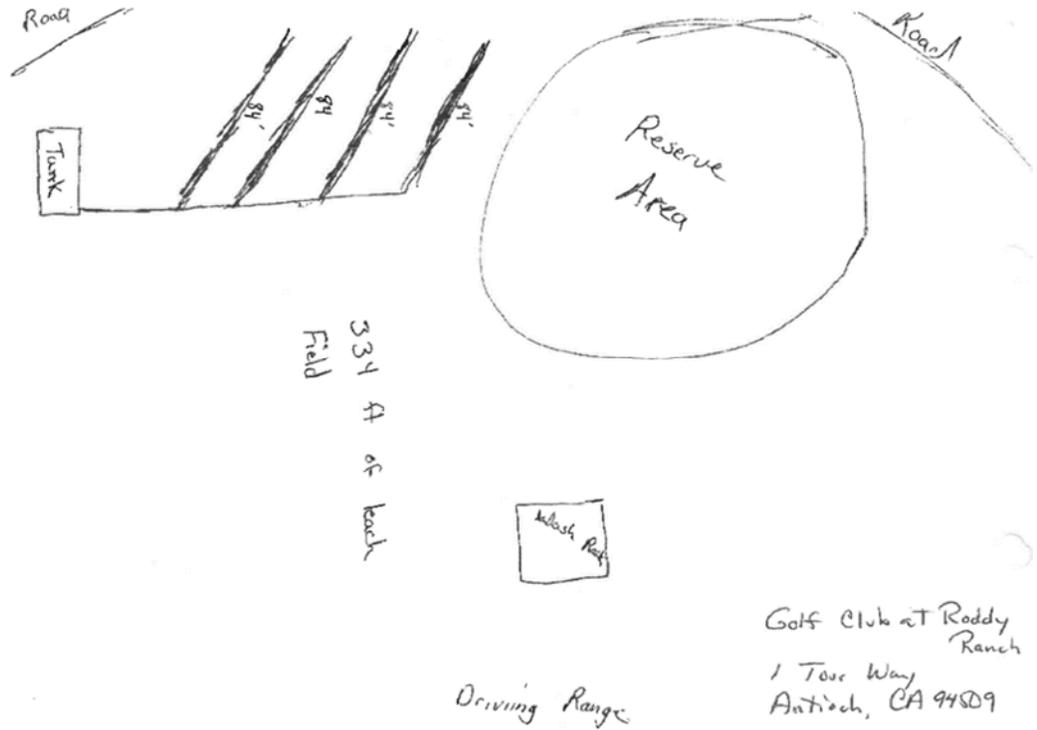
Figure 3: Septic Tank and Leach Field (from Permit Application)

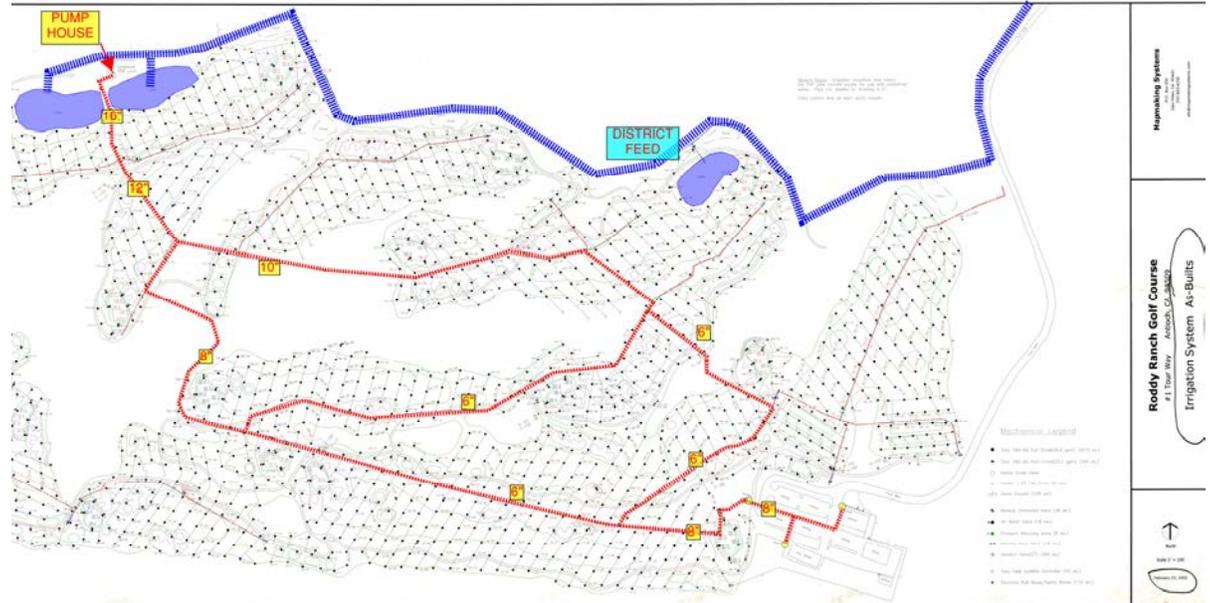
Figure 11: Existing Irrigation/Fire Mains

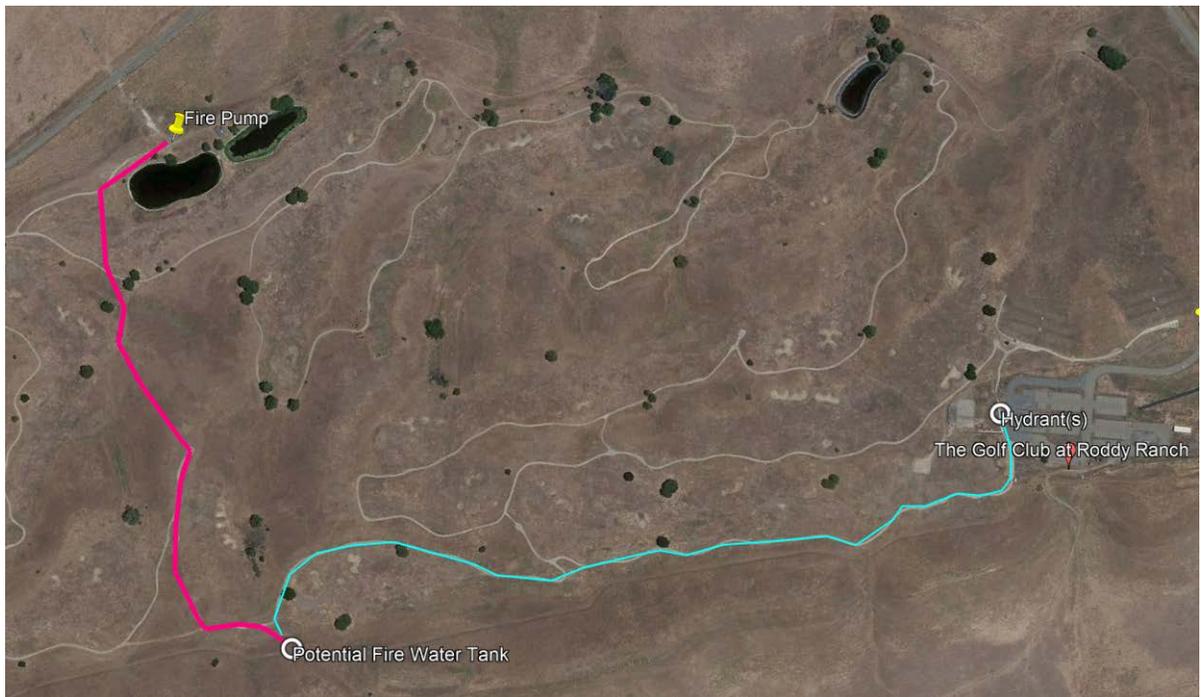
Figure 12: New Fire System with Pump and Tank

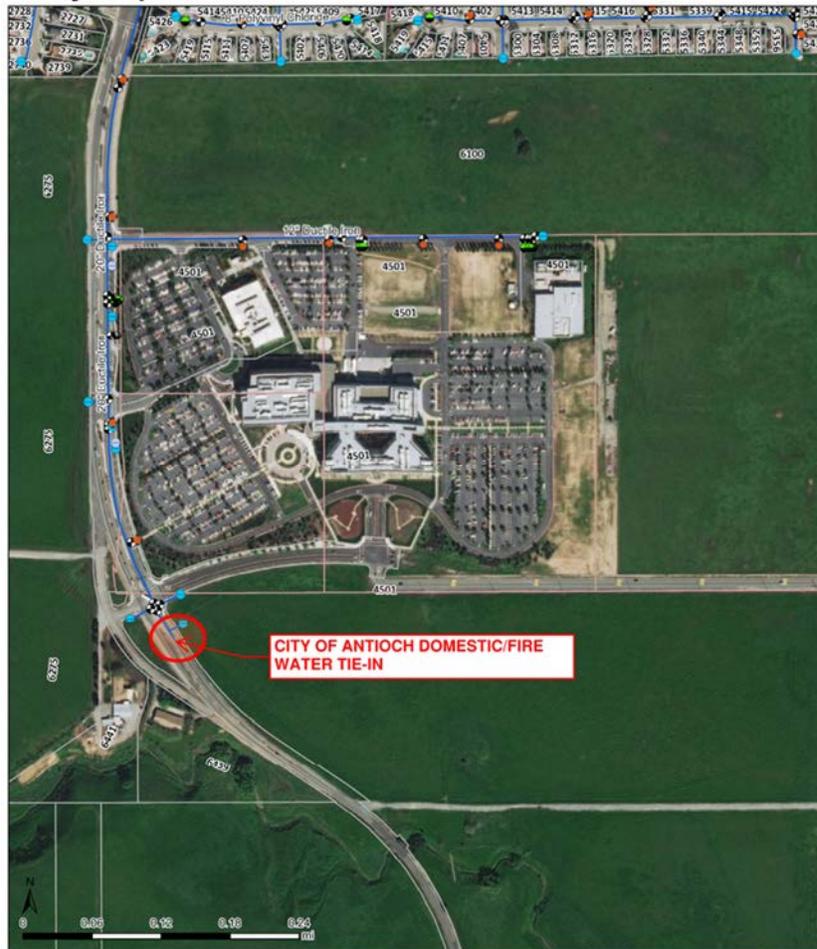
Figure 13: Deer Valley Water Tie-In

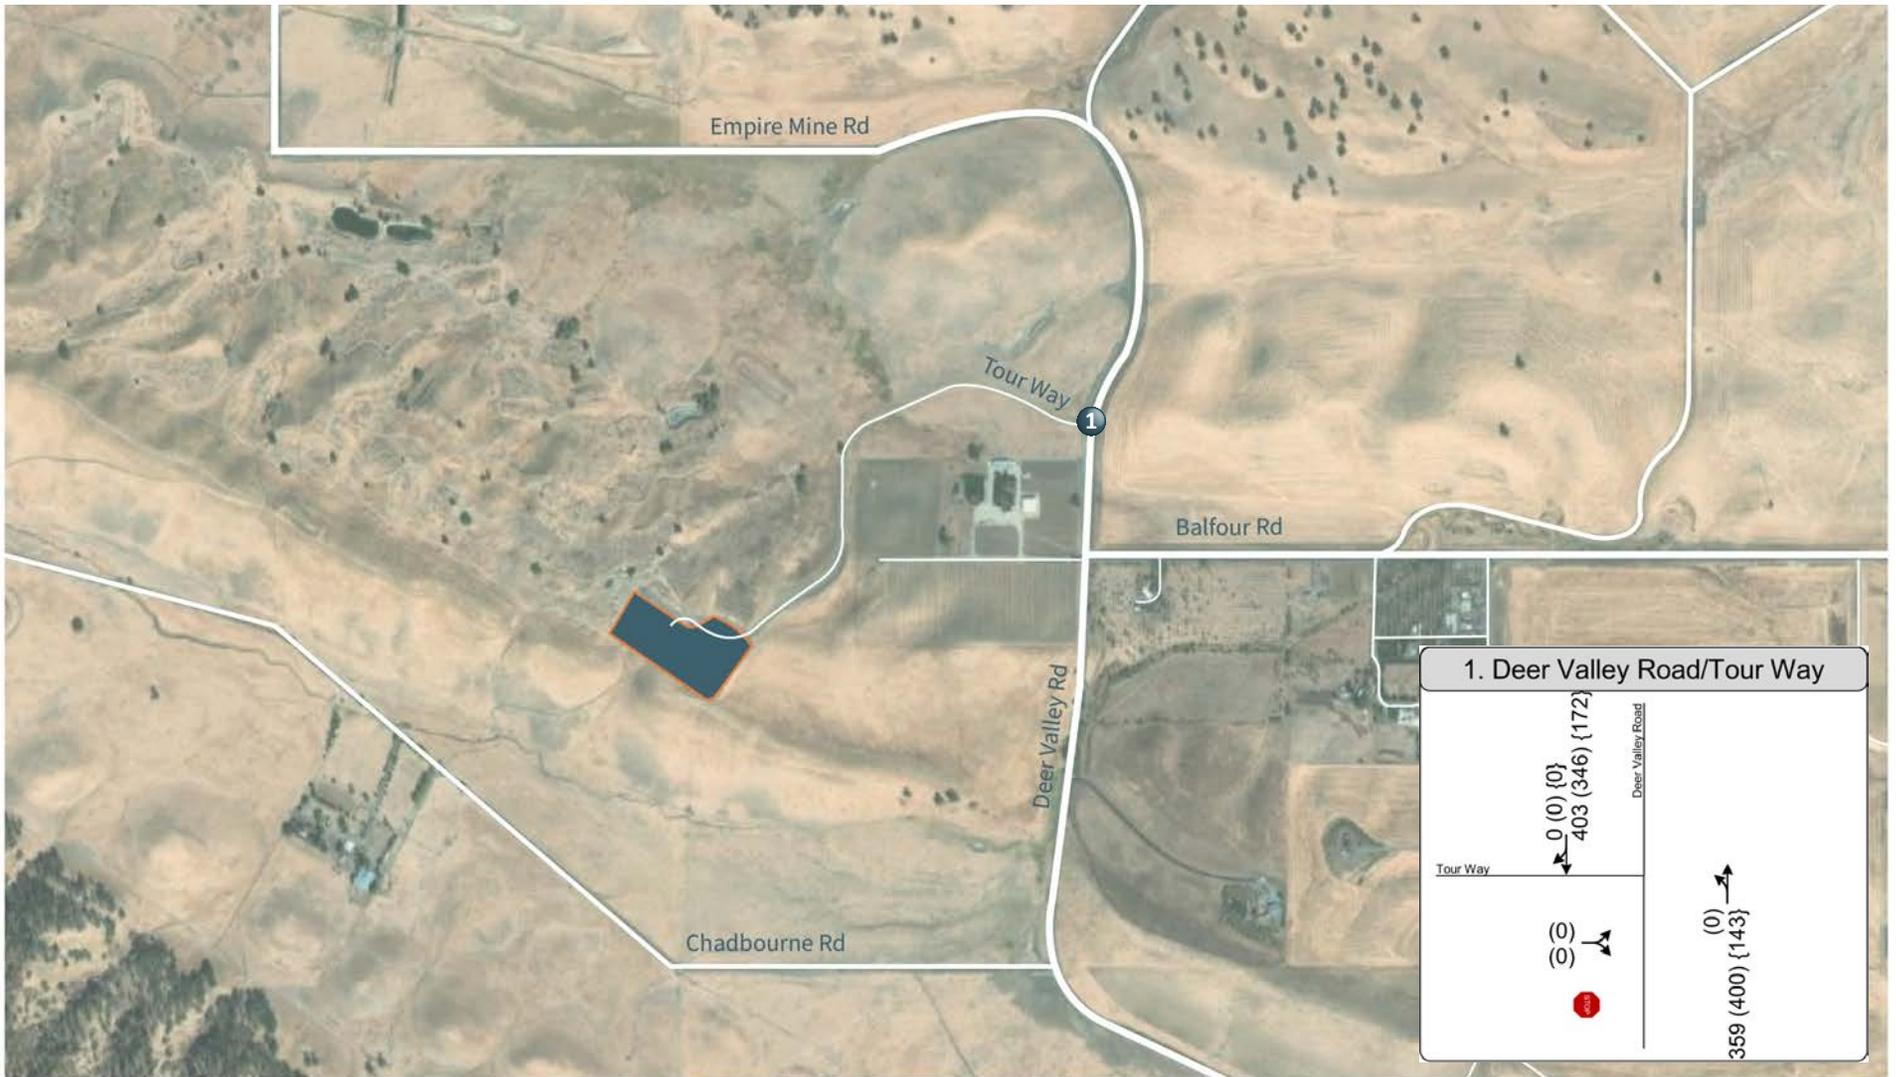
Figure 2  
 Traffic Volumes, Lane Configurations, and Traffic Control  
 Existing Peak Hour

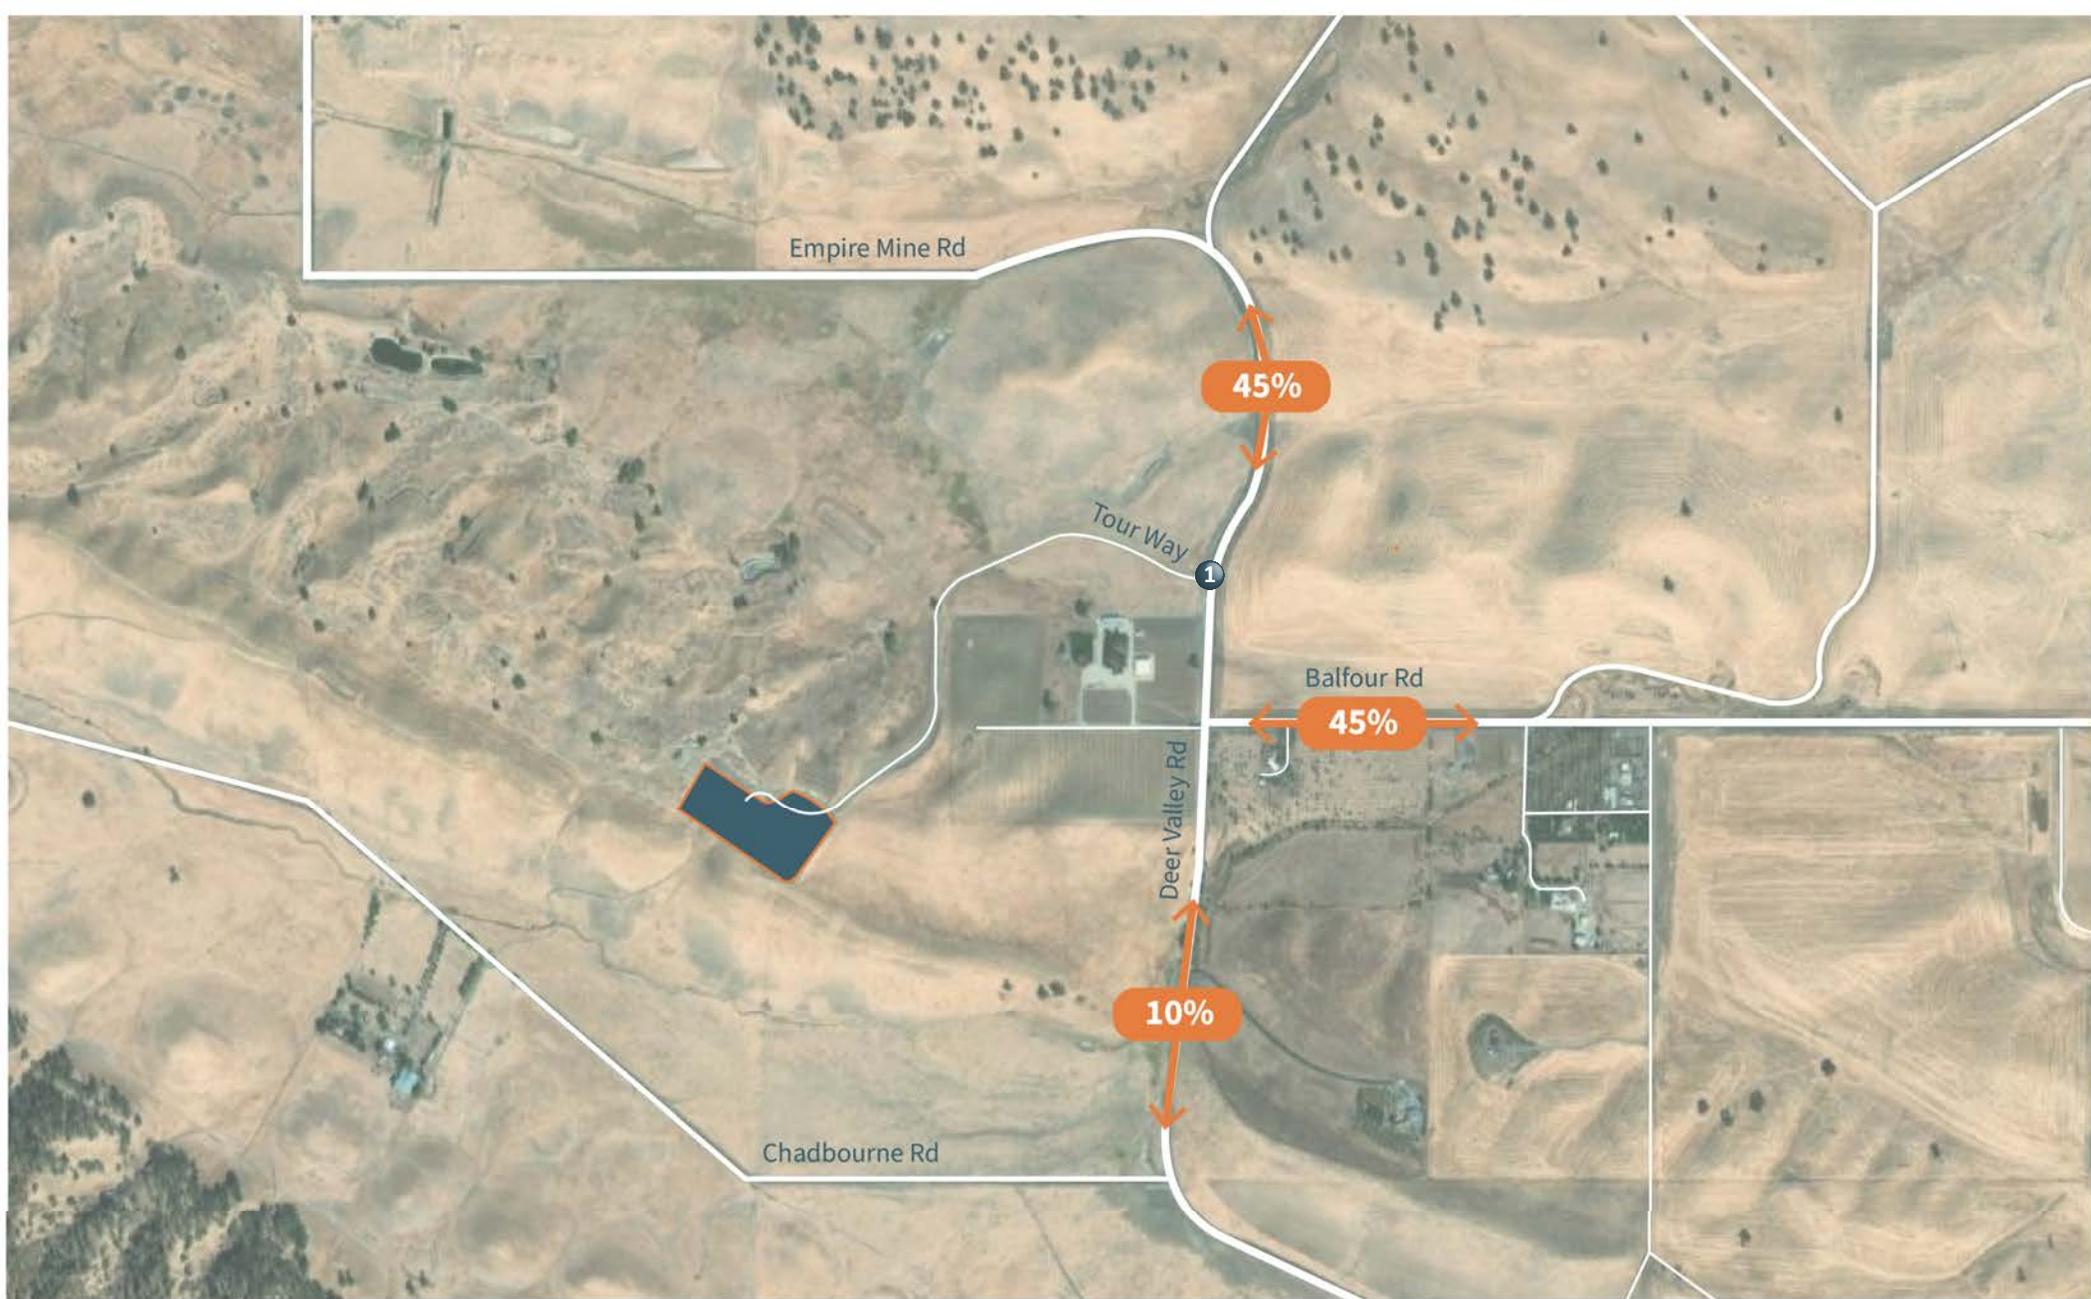
## Project Trip Distribution

- Project Site
- Trip Distribution
